Subject: Town of Huntsville Operation Centre - Madill - Building Condition Assessment

BUILDING CONDITION ASSESSMENT

169 Madill Church Road, Huntsville Ontario

TULLOCH Project #: 21-1405

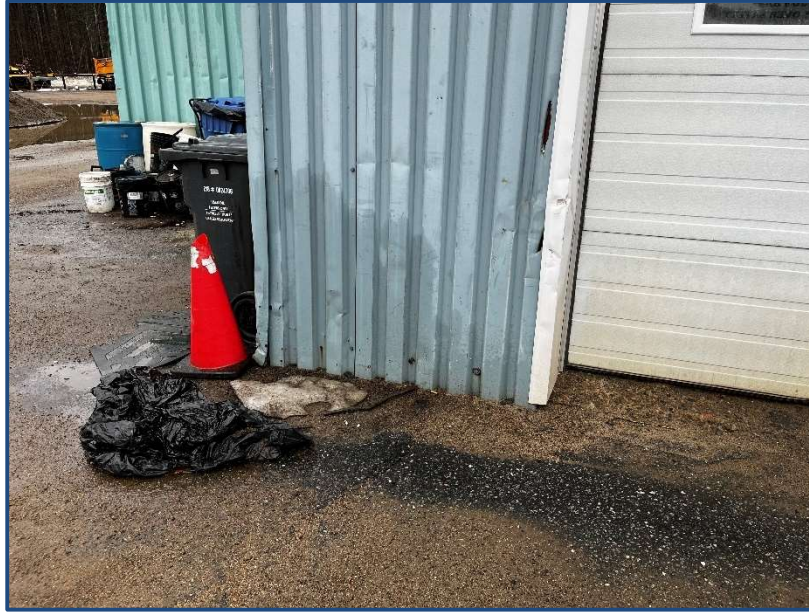
1. Impact damage to the structures metal siding and garage door frames. Areas of exposed and wet insulation at impact damage to siding.

Picture 1: Impact Damage to Siding and Garage Door Frame – Southwest Corner

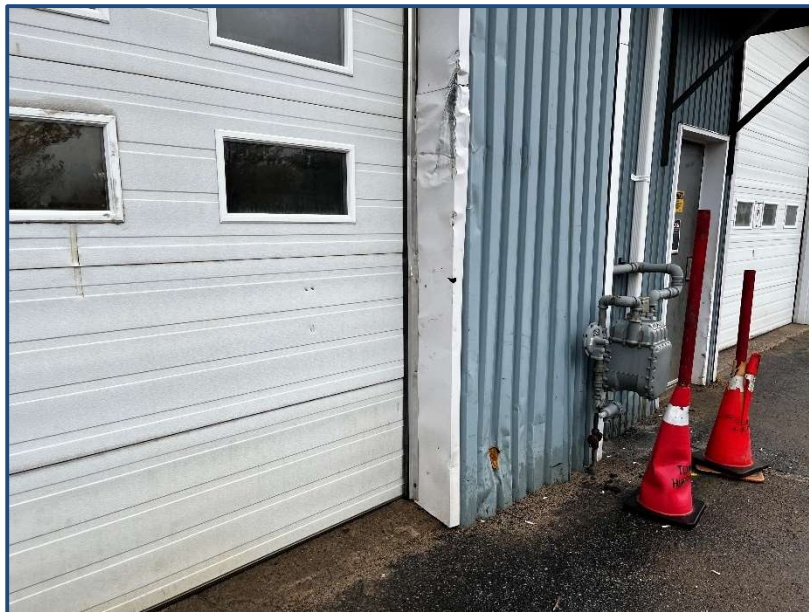
Picture 2: Impact Damage to Garage Door Frame

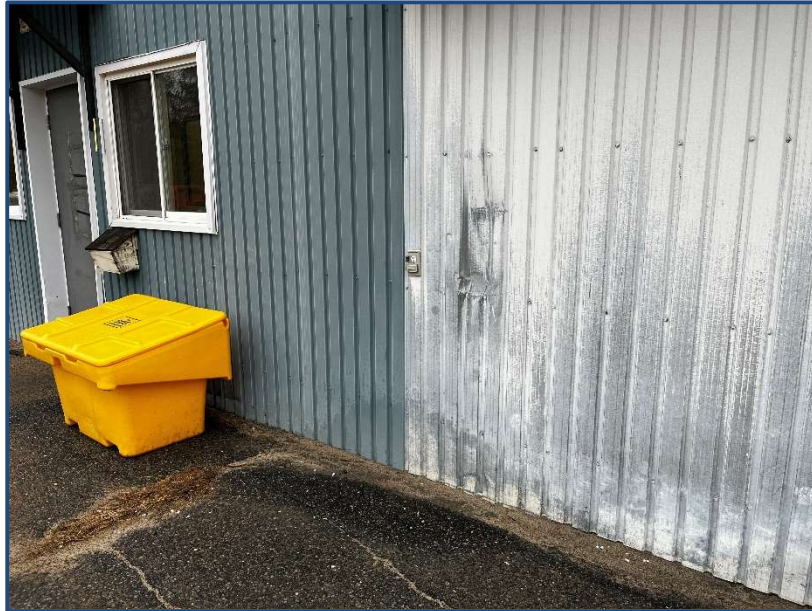
Picture 3: Impact Damage to Siding of First Floor Offices

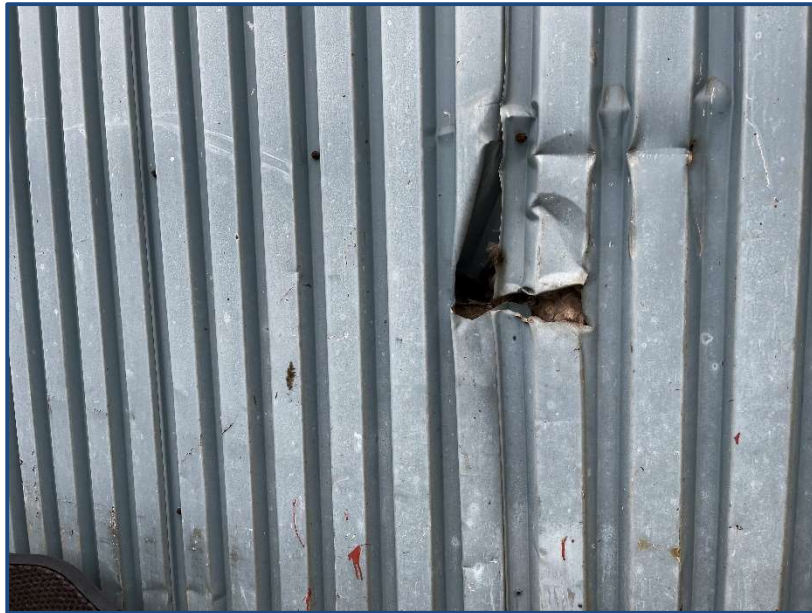
Picture 4: Impact Damage to North Siding of Garage No. 2

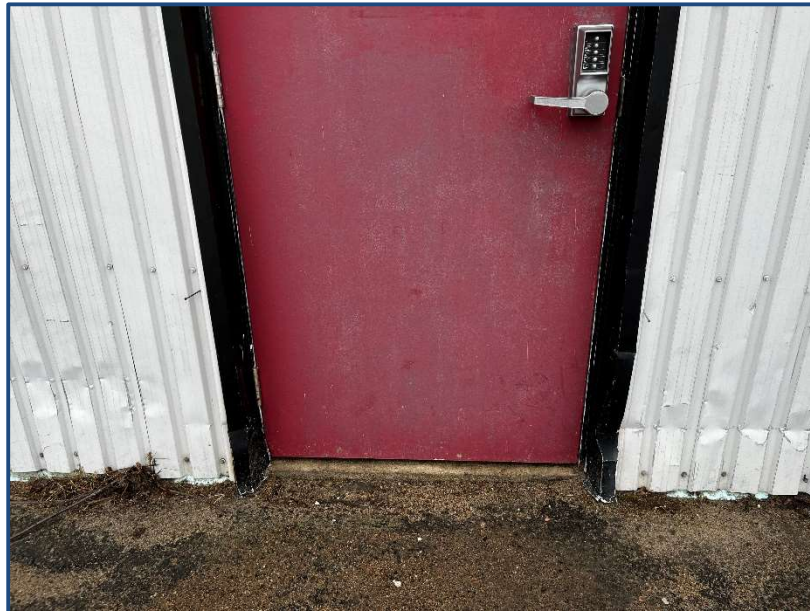
Picture 5: Damaged Siding at Main Entrance

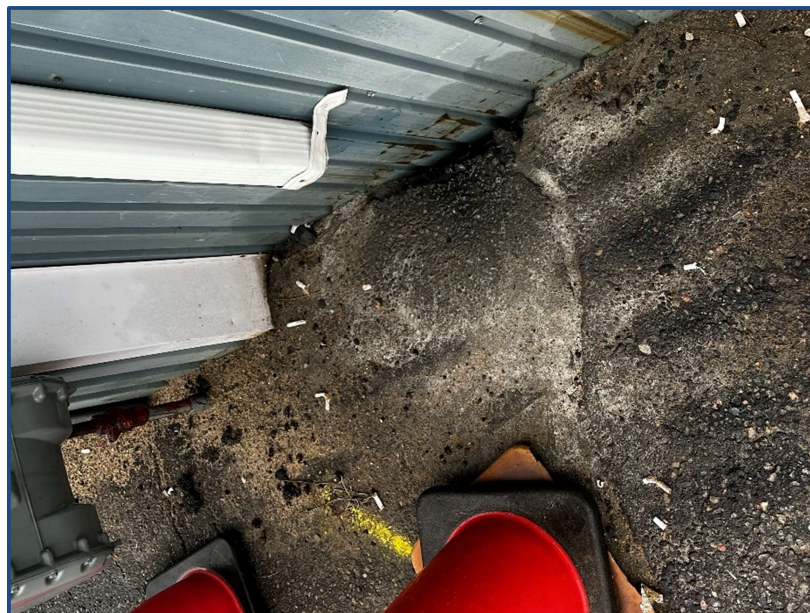
2. Roof drain eroding asphalt and gravel beneath the building's south wall. Erosion depth 9" below grade. Northwest eavestrough downspout crushed from tire leaning on it, flow limited.

Picture 6: Roof Drain Eroding Asphalt

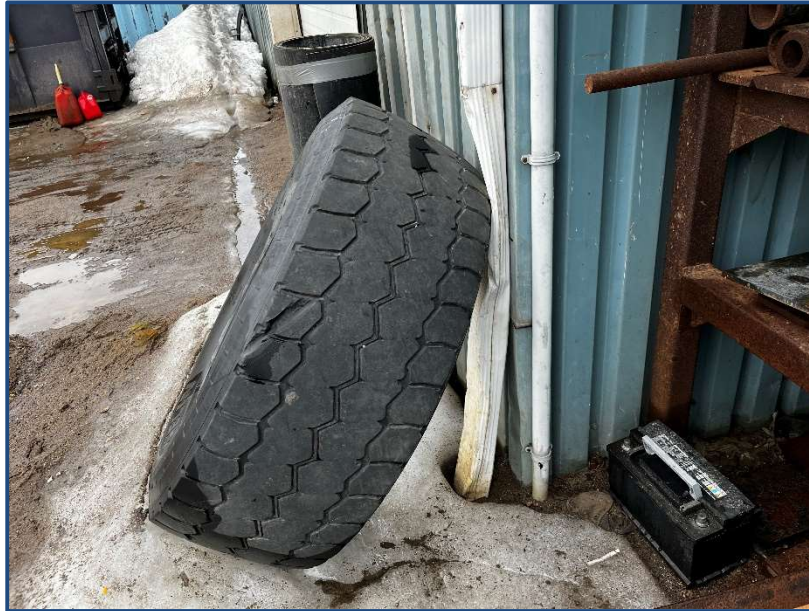
Picture 7: Northwest Crushed Eavestrough Downspout

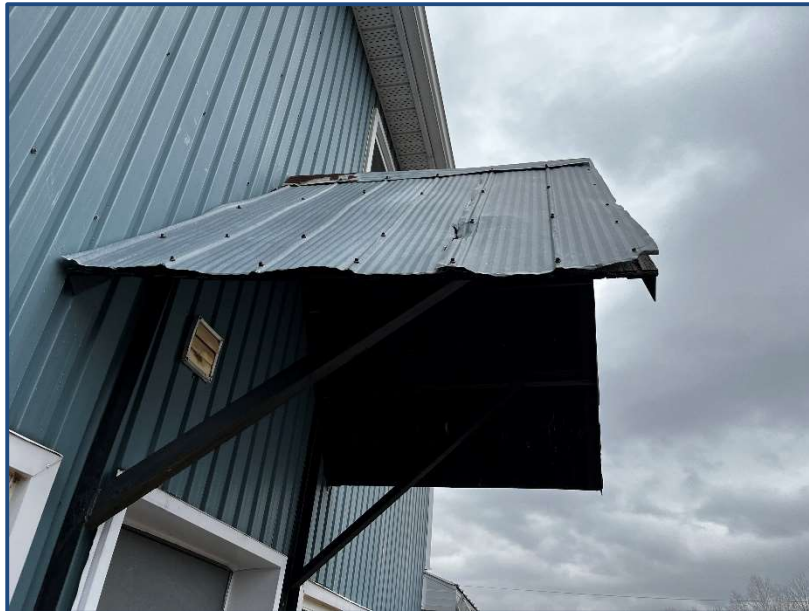
3. Damaged canopy over the south man door entrance. North side entrance canopy in poor condition. Light corrosion of steel structure, steel connections secured by only tack welds, and canopy to building connections made with only one bolt per connection point.

Picture 8: Damaged South Entrance Canopy

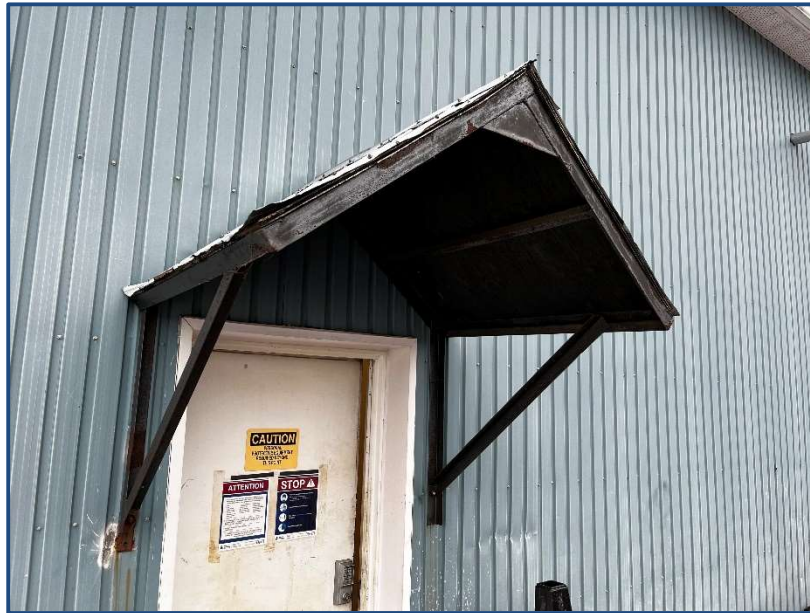
Picture 9: North Garage Side Entrance Canopy

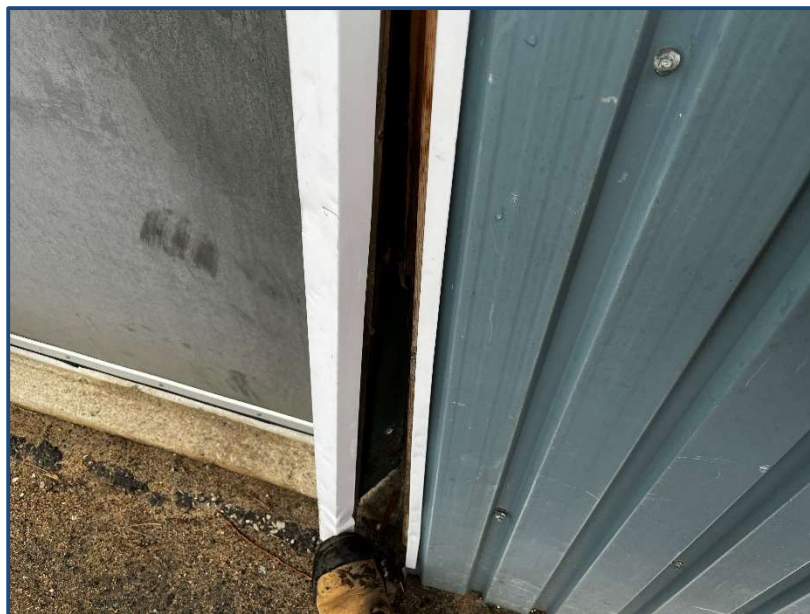
4. Damaged south office man door entrance flashing. Separation of the flashing from the door frame.

Picture 10: South Office Man Door Entrance – Flashing Separation

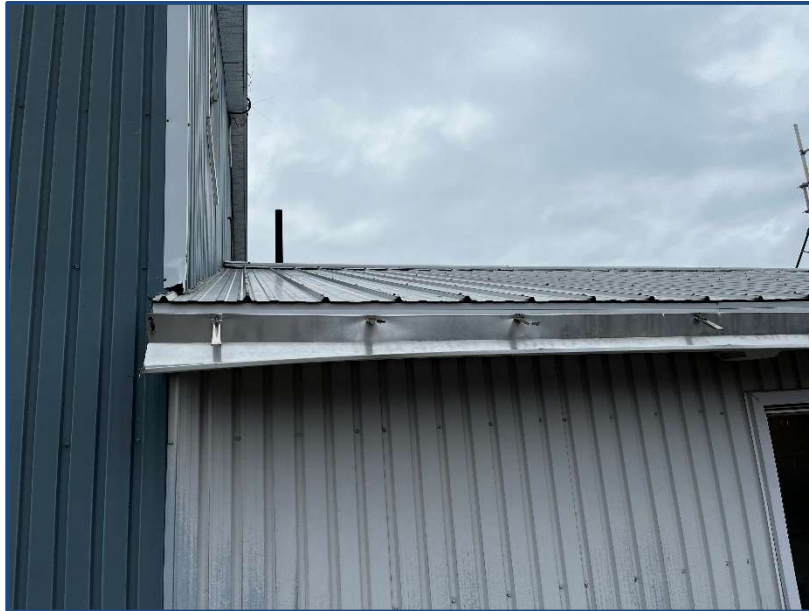
5. First floor office's eavestrough system damaged from ice sliding. Reported by Huntsville operation Centre employee that all eavestrough installed on First Floor Offices get damaged in the same manner.

Picture 11: Damaged Eavestrough on First Floor Offices

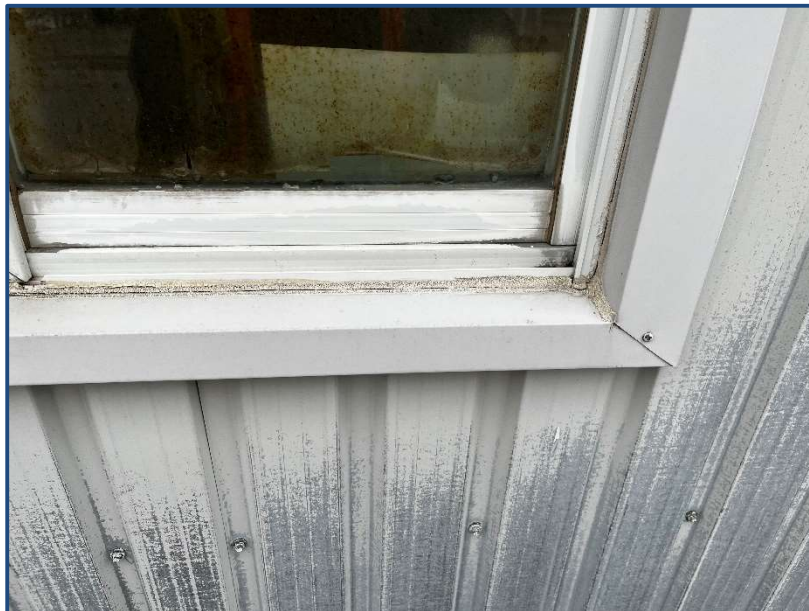
6. Failed caulking around window of First Floor Office section.

Picture 12: Failed and Cracked Caulking on First Floor Offices Windows

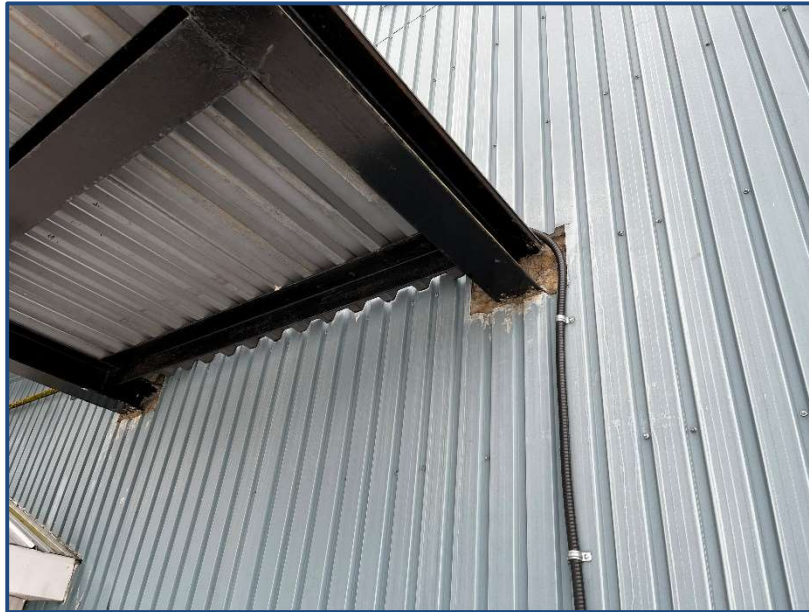
7. Siding cut out for heating unit steel support beams, insulation exposed and wet.

Picture 13: Metal Siding Cut for Heating Unit's Steel Structure

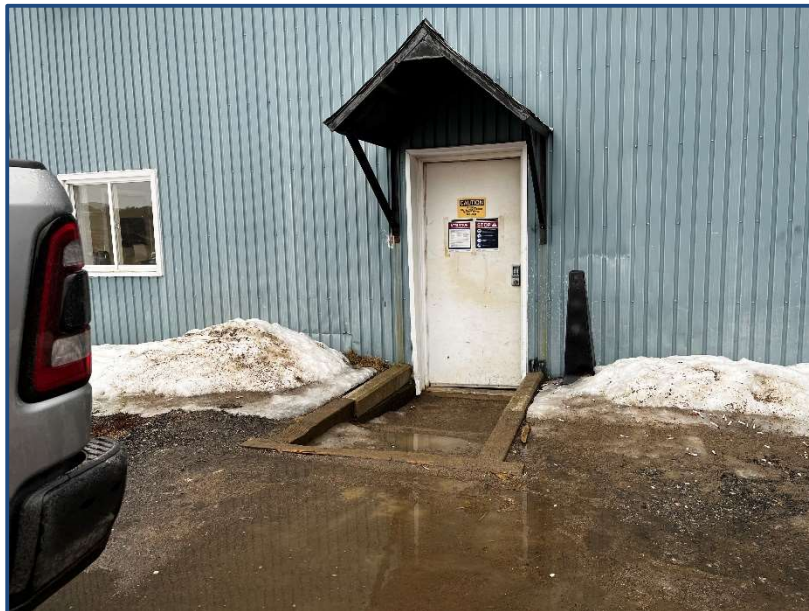
8. Garage No. 1 north side entrance approximately 1 ft below grade, a Huntsville Operation Centre employee notes that flooding of Garage No. 1 occurs every spring through this door. The parking lot slopes towards building, funneling water towards this side entrance.

Picture 14: North Garage Side Entrance Below Grade – Watering Pooling at Entrance

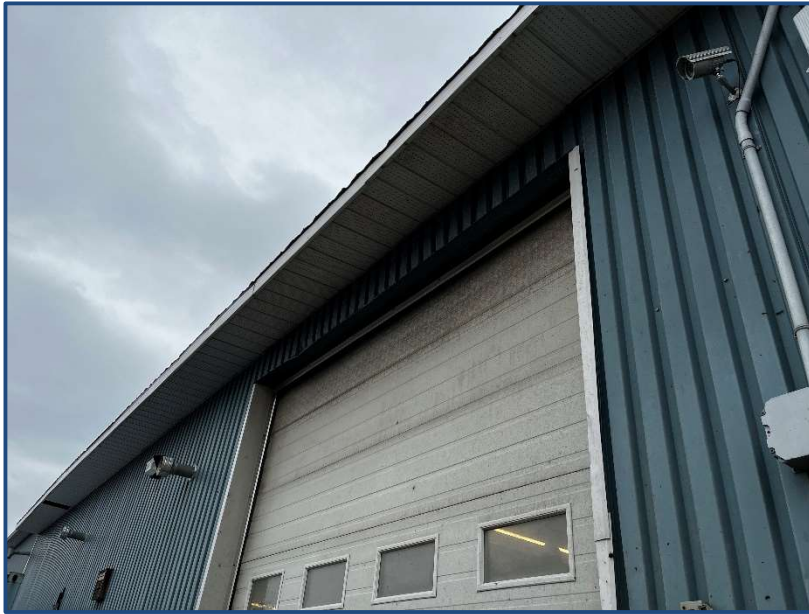
9. Damage to the garage door frame at Garage No. 2's north garage door.

Picture 15: North Garage Door – Damage to Top Left of the Doors Frame

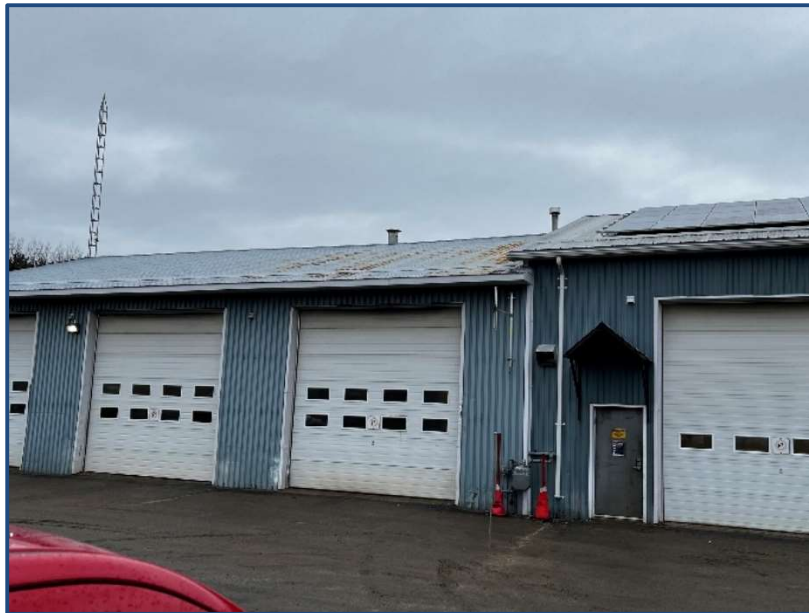
10. Corrosion on metal roof of Garage No. 2.

Picture 16: Corroded Metal Roof Panels

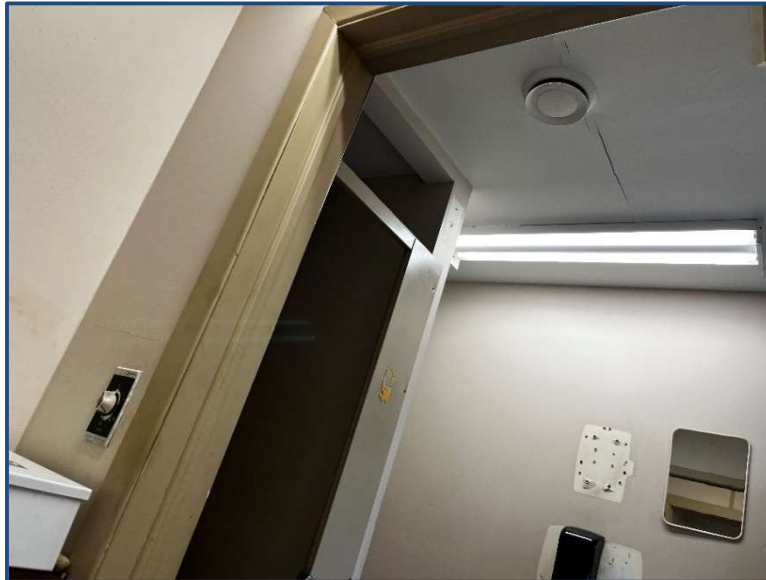
1. Crack in ceiling paint in the men's washroom, likely caused by moisture.

Picture 17: Crack in Men's Washroom Ceiling Paint

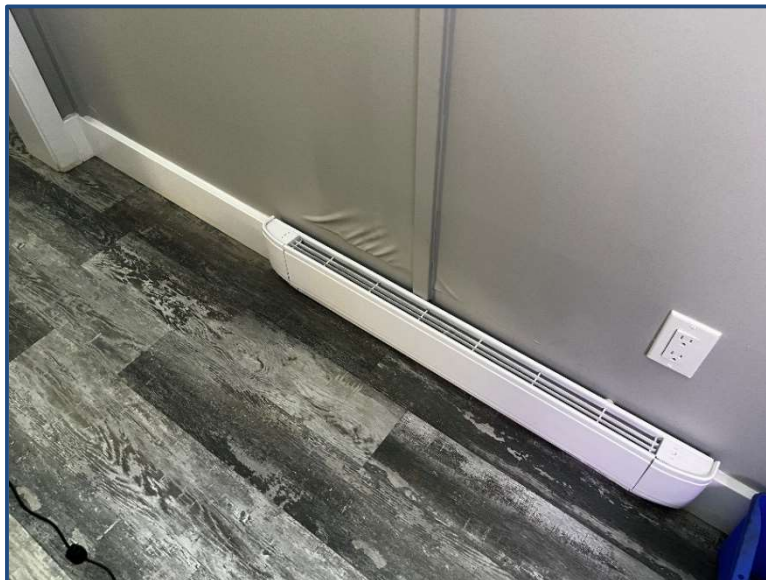
2. Paint bubbling above heater in northeast office, likely caused by moisture.

Picture 18: Paint Bubbling above Heater

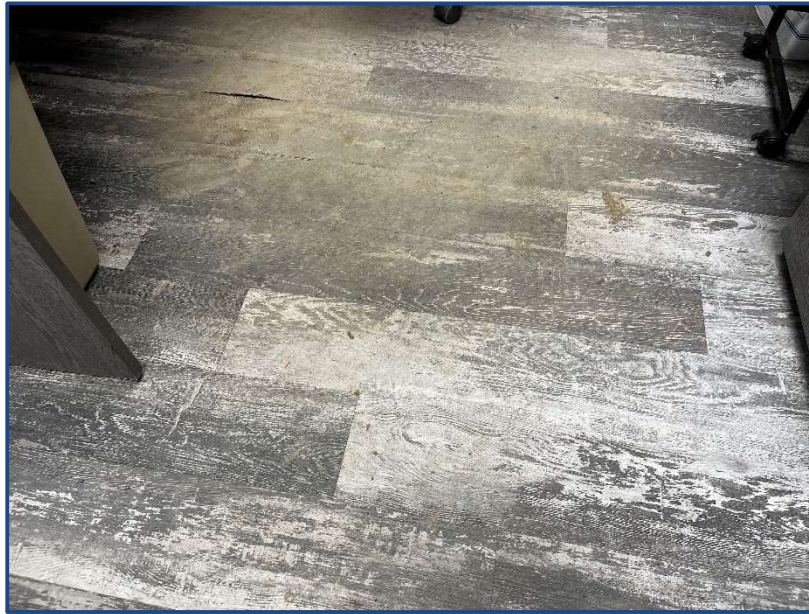
3. Vinyl plank flooring damaged in offices beneath desk areas.

Picture 19: Damaged Vinyl Plank Flooring – Southeast Office

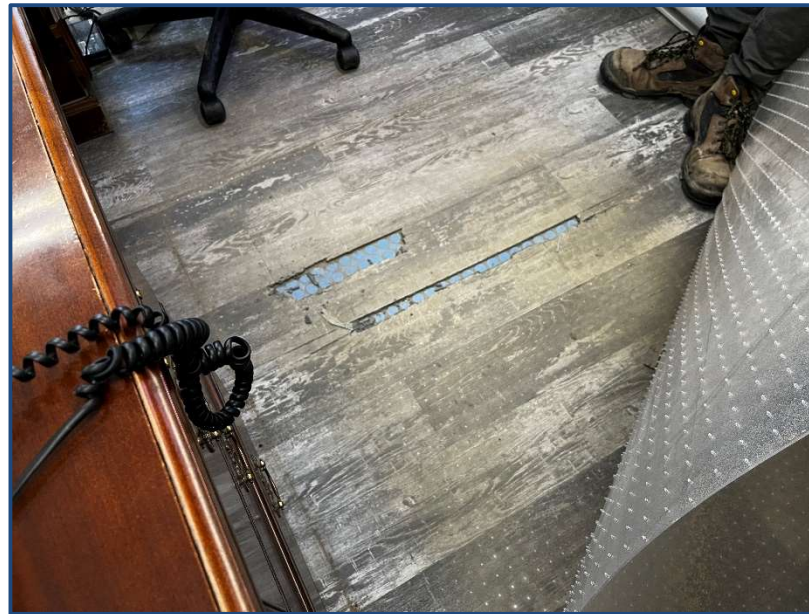
Picture 20: Damaged Vinyl Plank Flooring – Northeast Office

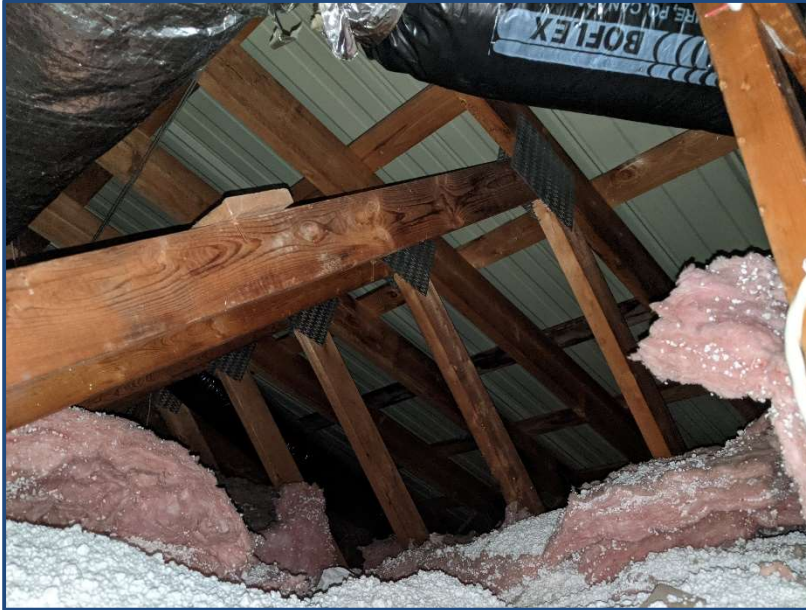
4. Moisture staining on timber truss above office area. The attic has poor insulation spread of batt insulation. Limited inspection of attic space.

Picture 21: Moisture Staining on First Floor Office Trusses

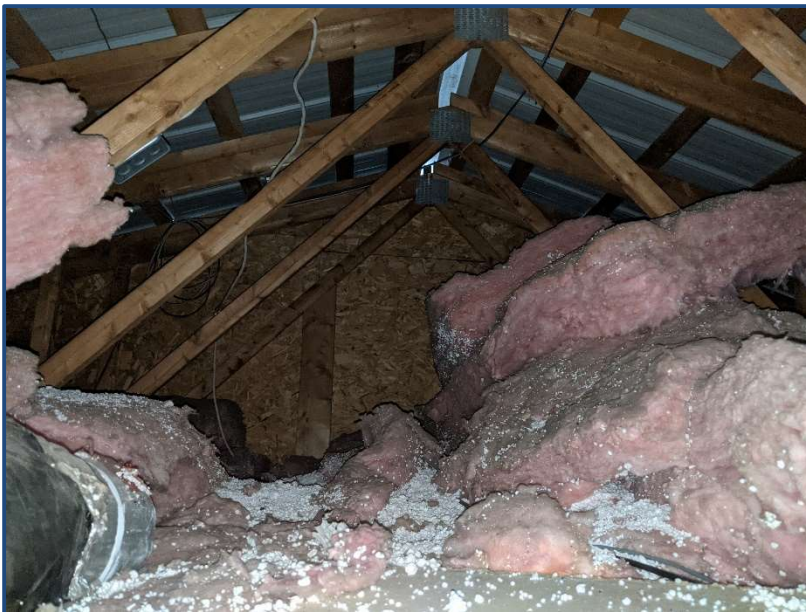
Picture 22: Poor Insulation Spread in First Floor Office Attic

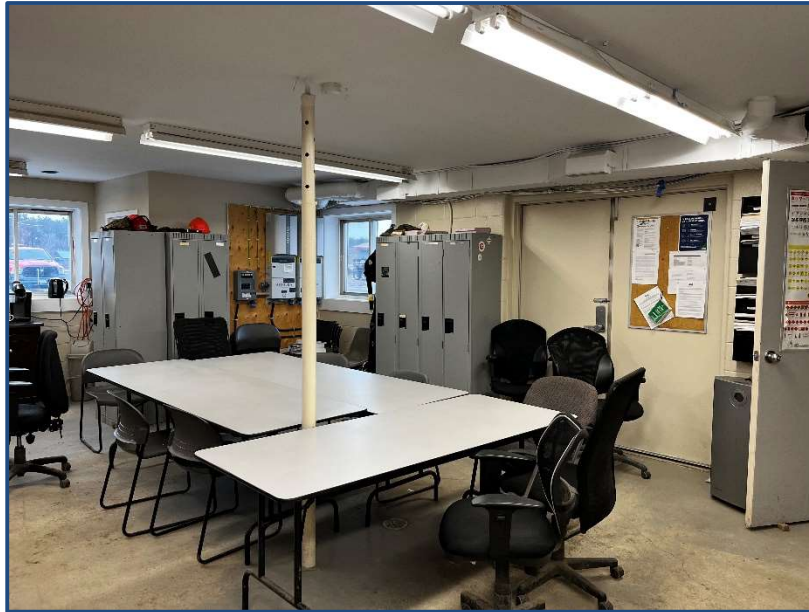
1. Jack post located in the lunchroom supporting the Second Floor Offices. The jack post is believed by the employees to be original to the structure.

Picture 23: Jack Post in Centre of Lunchroom

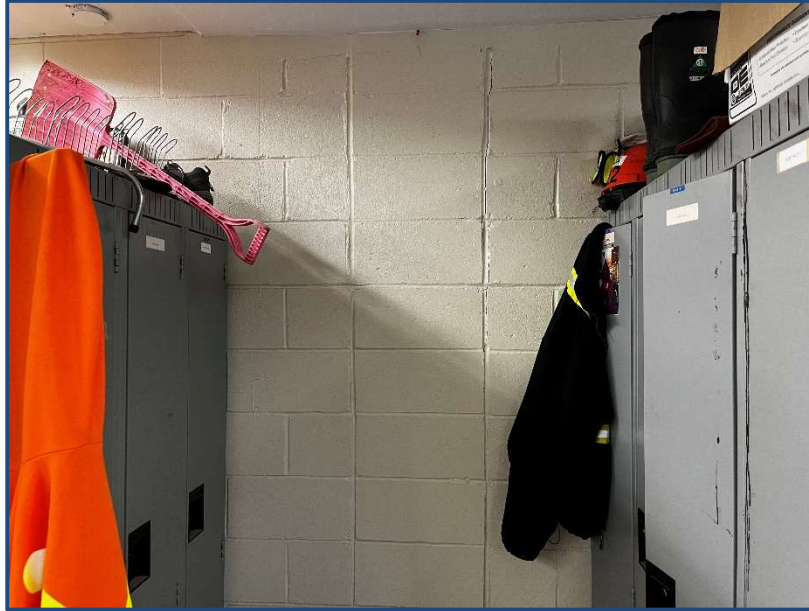
2. Separation of the concrete block wall and column along the west wall of the lunchroom. Step cracking above window in the north wall of the lunchroom. Indicates movement of structure.

Picture 24: Separation of Concrete Block Wall and Column

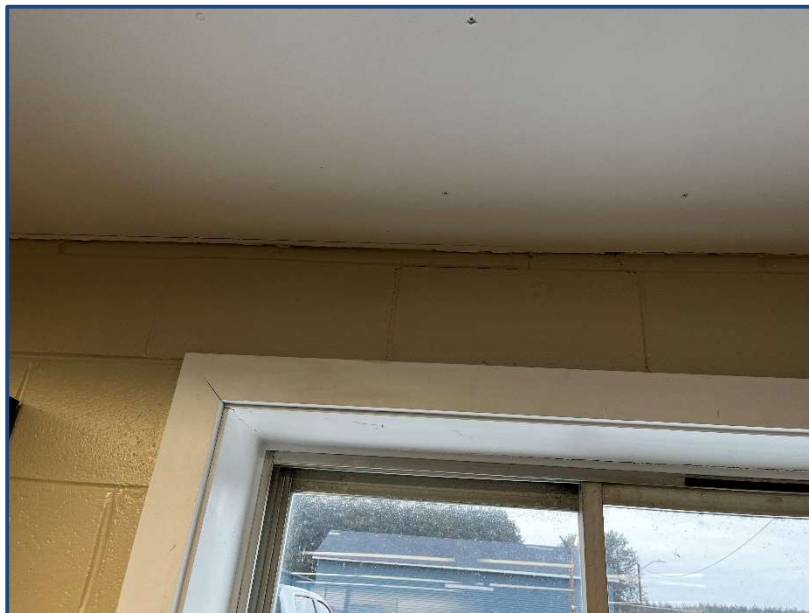
Picture 25: Step Cracking in North Concrete Block Wall

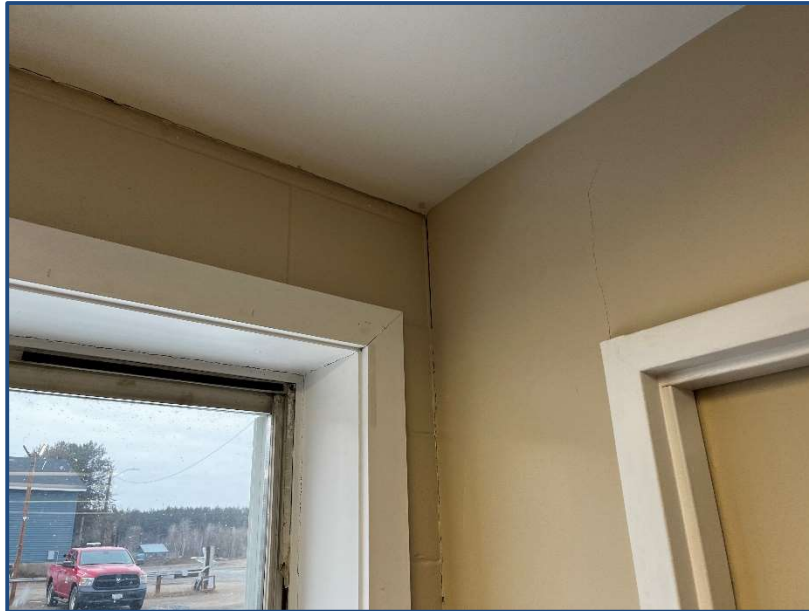
3. Cracking in drywall above interior door frame in northeast corner of the lunchroom. Water damage at base of drywall by the south man door side entrance. Indicates movement of structure.

Picture 26: Cracking of Drywall above Interior Door Frame

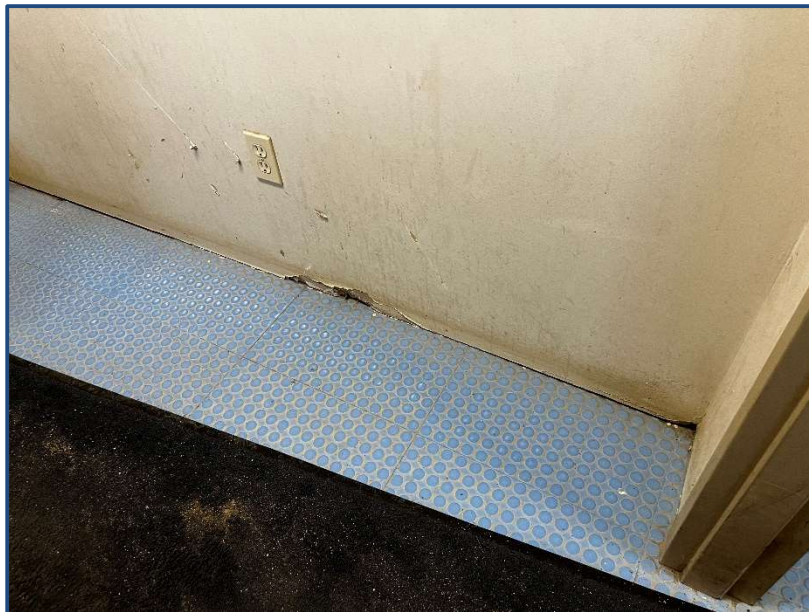
Picture 27: Water Damage at Drywall Base – South Man Door Entrance

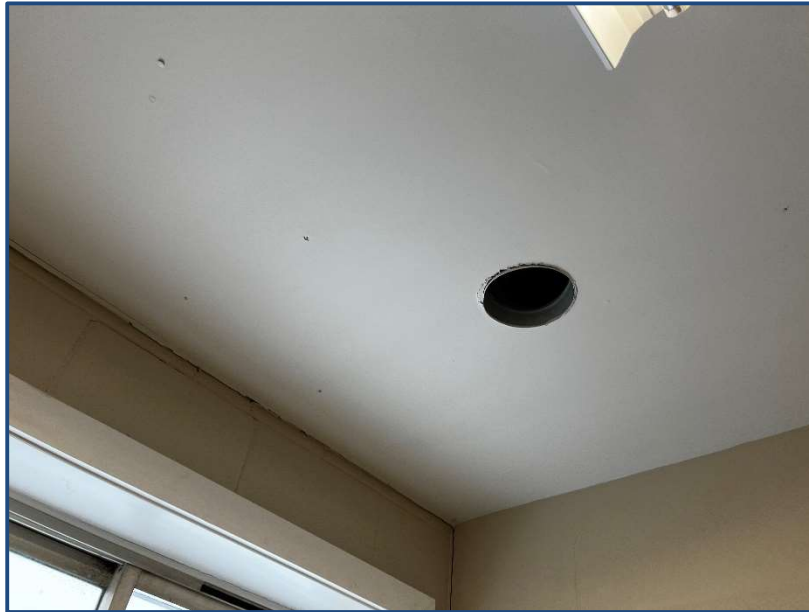
4. Non covered air vent present in Lunchroom ceiling.

Picture 28: Air Vent Missing Cover – Lunchroom

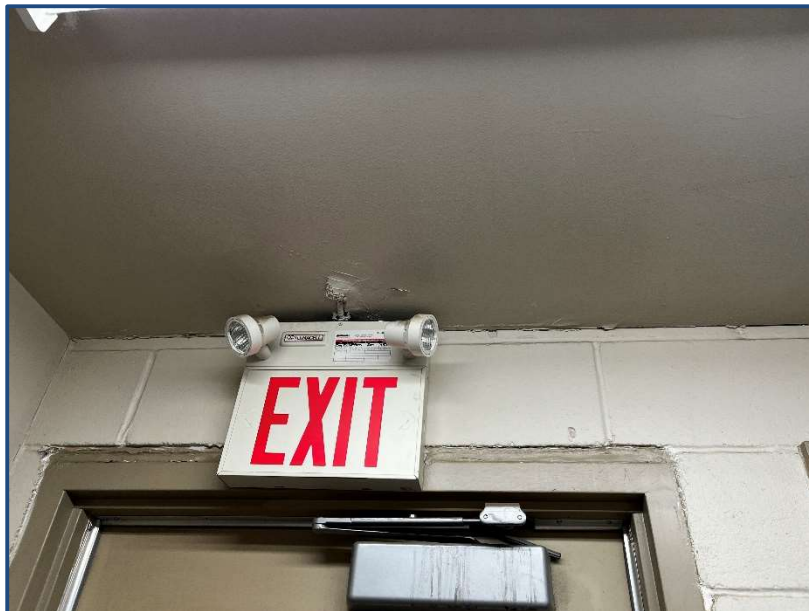
5. Minor drywall cracking above exit sign. Door closer is broken, causing the door to slam shut upon release.

Picture 29: Minor Drywall Cracking and Broken Door Closer

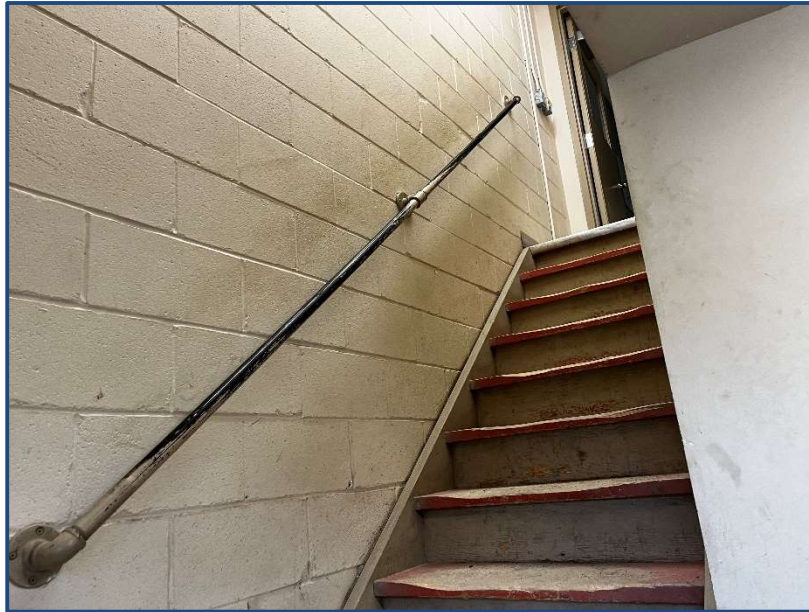
6. The staircase from the first floor to the Second Floor Offices has severe wear and rutting on the travel path. The wear is posing a significant tripping hazard on the staircase.

Picture 30: Severe Wear of the Stair Treads

The Locker and Lunchroom areas are in fair condition, with the lunchroom area being in good condition, but the stairwell to the Second Floor Offices in poor condition. The stairwell poses significant health and safety concern as it is not constructed to the Ontario Building Code requirements. It has severe wear and rutting on the travel path along the stairs, the handrail does not run full length of the stairwell, and the handrail is connected to the wall in a manner that prevents the railing from being graspable along its entire length.

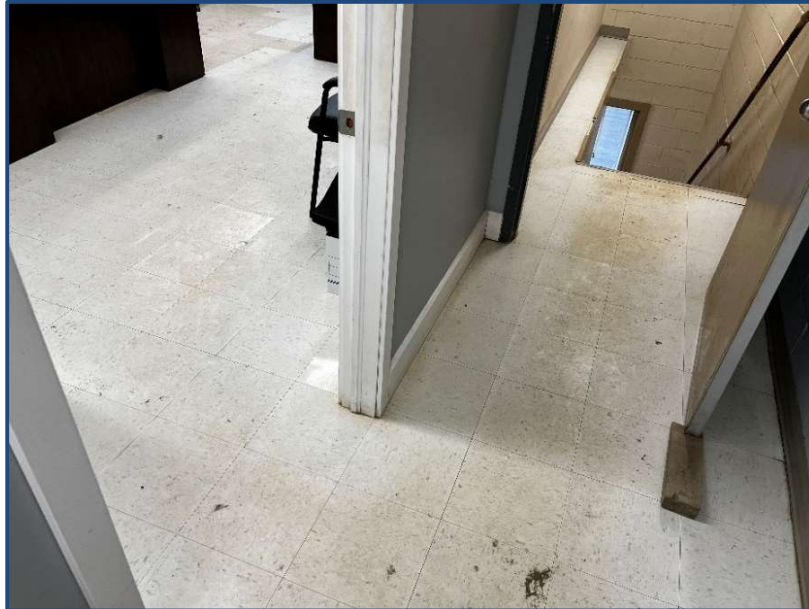
1. Wear of vinyl tiles at stairwell to the offices on the second floor.

Picture 31: Wear of Vinyl Floor Tiles

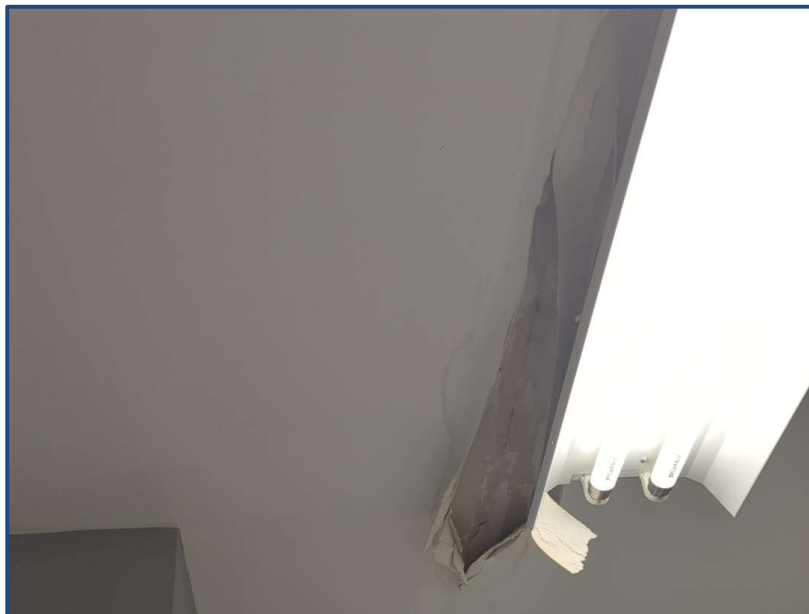
2. Water damage to ceiling adjacent to light, near staircase.

Picture 32: Water Damage to Ceiling

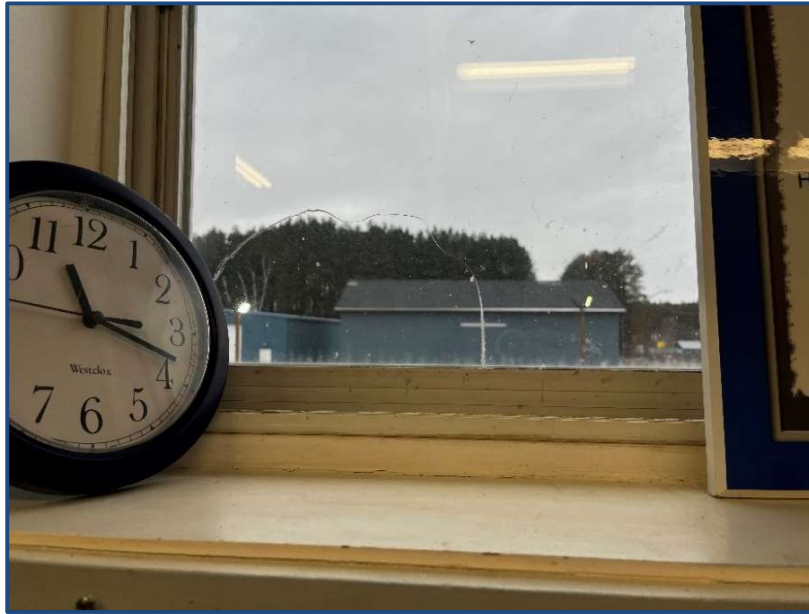
3. Window on north wall of the Second Floor Offices is cracked.

Picture 33: Cracked Window on North Wall of Second Floor Office

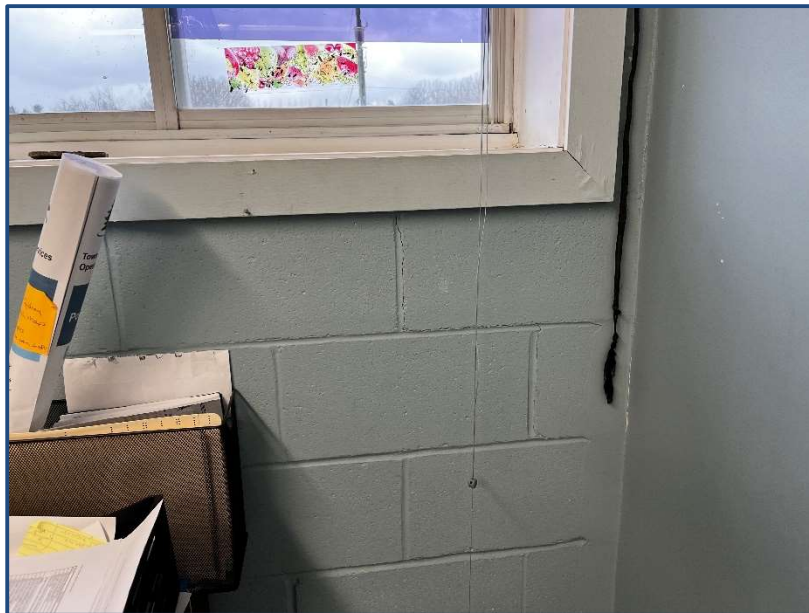
4. Narrow step cracking in east concrete block wall of the Second Floor Offices.

Picture 34: Narrow Step Cracking in Concrete Block Wall – East Wall

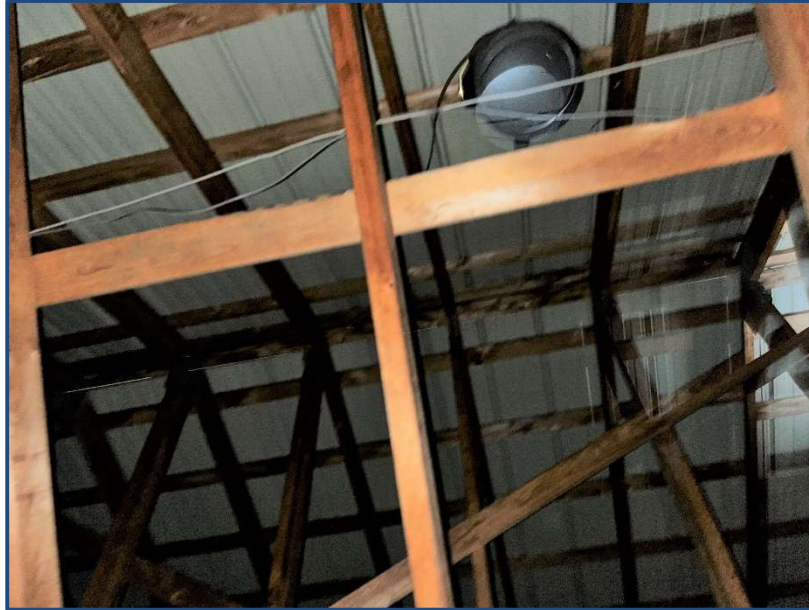
5. Localized water staining on roof trusses in the attic of the Second Floor Offices. Limited inspection of attic area.

Picture 35: Localized Water Staining in Second Floor Attic

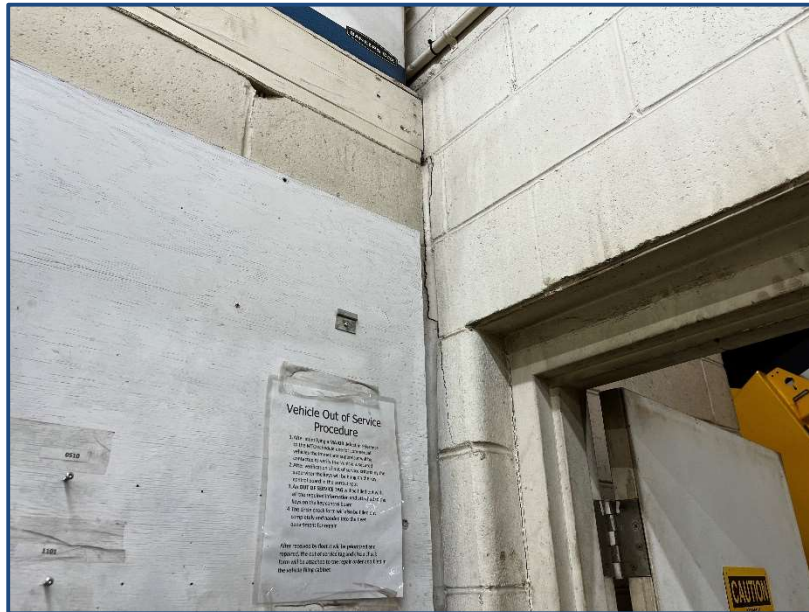
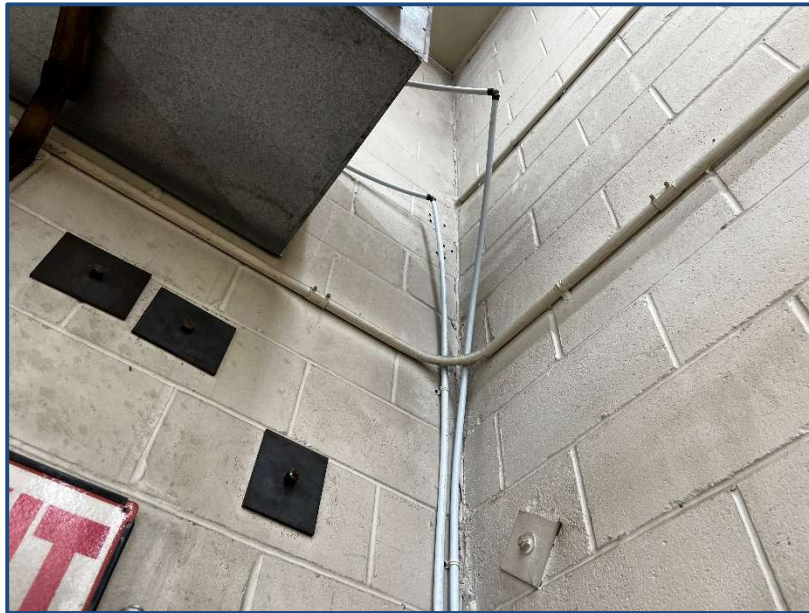
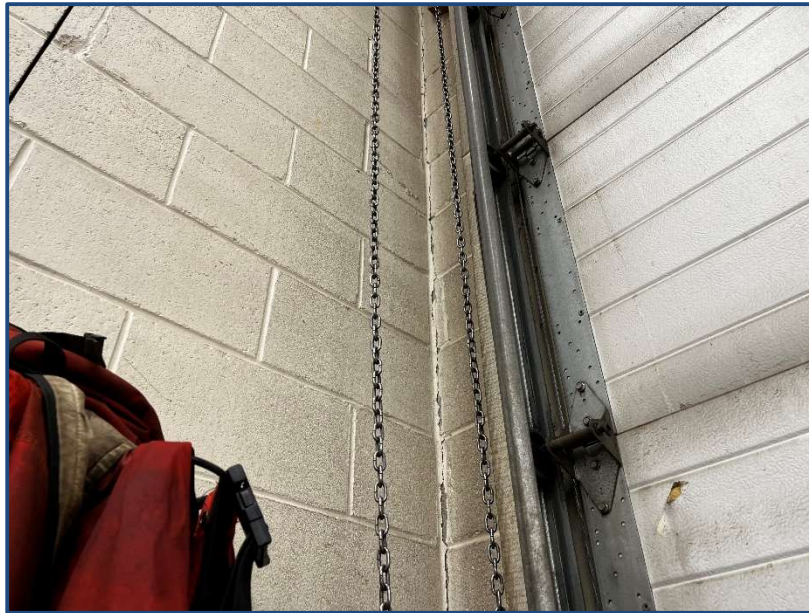
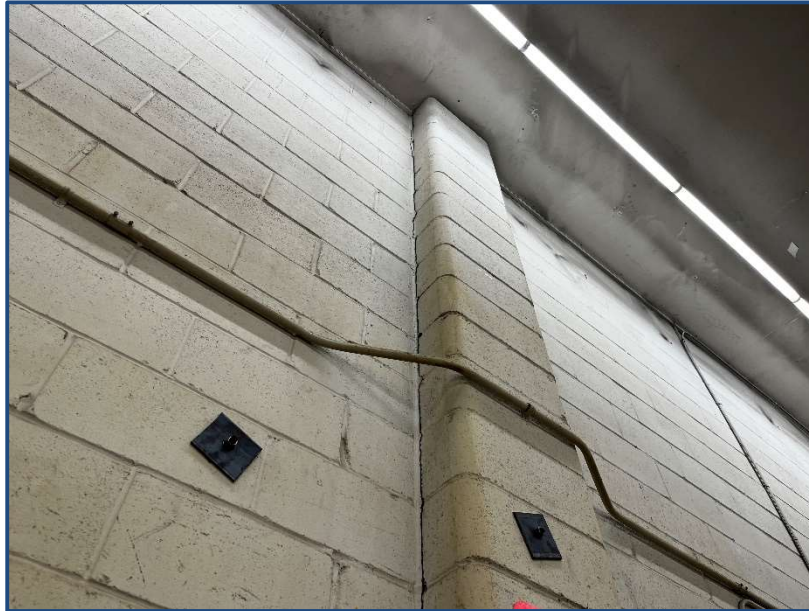
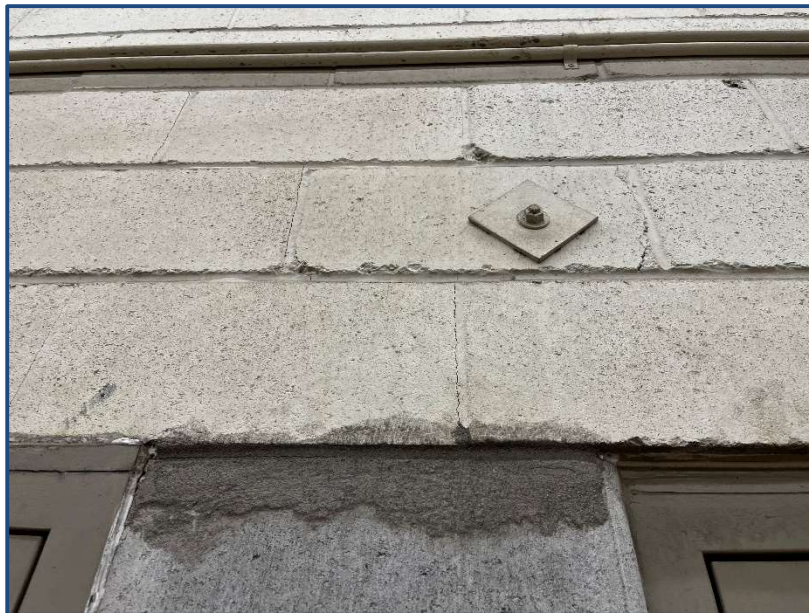
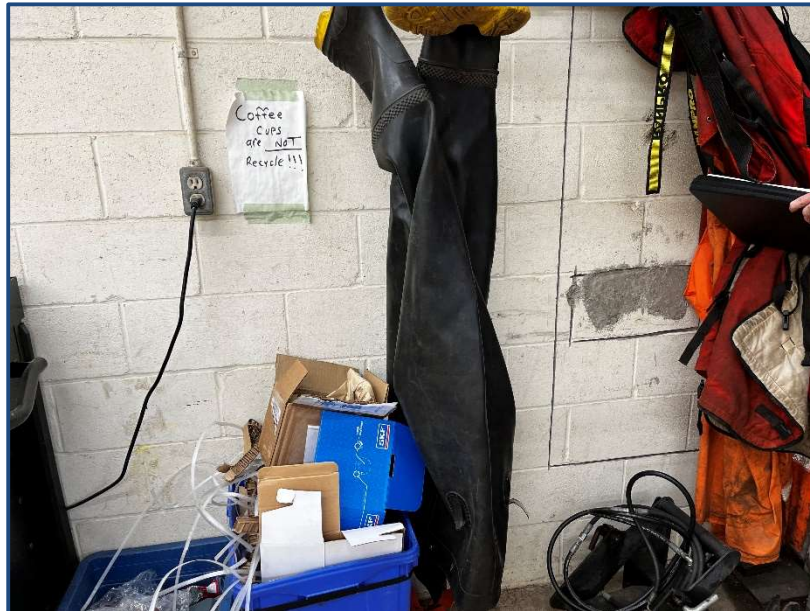
1. Narrow step cracking above the door between Garage No. 1 and No. 2. Medium to wide cracking in block wall directly south of doorway. The concrete block wall has a full height medium to wide crack at the northeast and southeast corners. Wide separation of the concrete block wall and block column along the east wall of the Garage No. 1. Step cracking in the block wall above two interior man doors along the east wall. Wide man-made cuts in the southeast corner of the concrete block wall, the purpose for the cuts is unknown.

Picture 36: Cracking in Block Wall between Garage No. 1 and No. 2

Picture 37: Cracking at Northeast Corner of Garage Block Wall

Picture 38: Cracking at Southeast Corner of Garage Block Wall

Picture 39: Full Height Wide Separation of Block Wall and Column

Picture 40: Step Cracking Above the Man Doors on the East Wall

Picture 41: Wide Cuts in the Southeast Corner of Garage No. 1

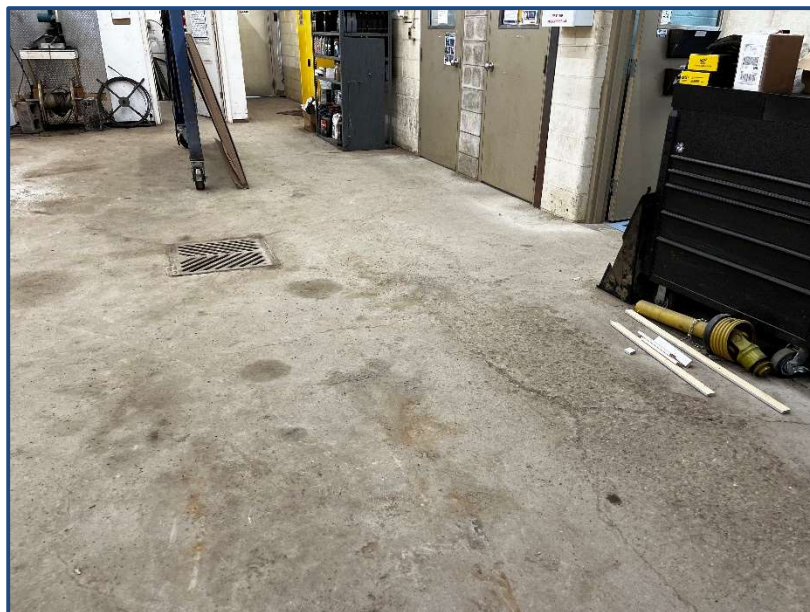
2. Map cracking and general wear damage in the concrete floor slab noted throughout. Areas of increase slab deterioration from wear located at the garage door entrance.

Picture 42: Garage No. 1 Concrete Slab – Map Cracking and Wear by Garage Door

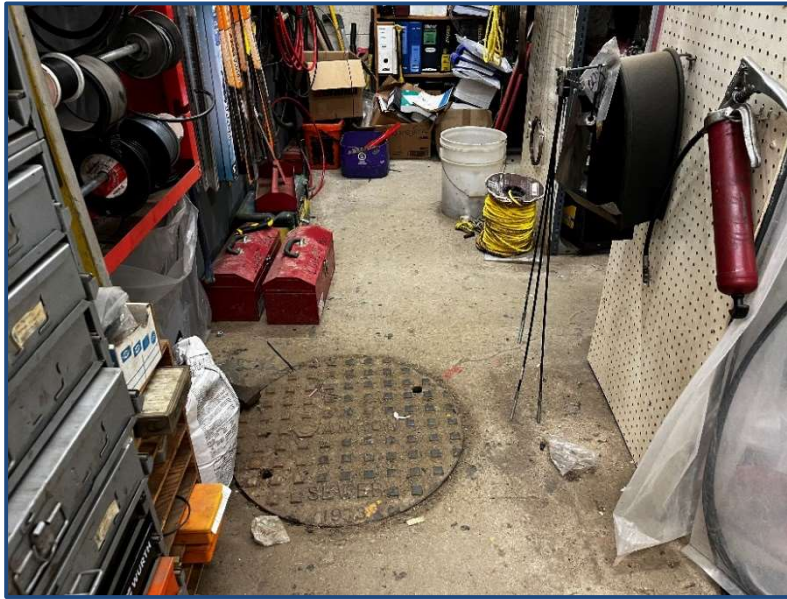
3. Odour of sewage in garage bay, originating from two sanitary sewer access point located within garage floor slab. Health and Safety Concern.

Picture 43: Sanitary Sewer Access Point within Garage No. 1
