Subject: Town of Huntsville Operation Centre - Madill - Building Condition Assessment

BUILDING CONDITION ASSESSMENT

169 Madill Church Road, Huntsville Ontario

TULLOCH Project #: 21-1405

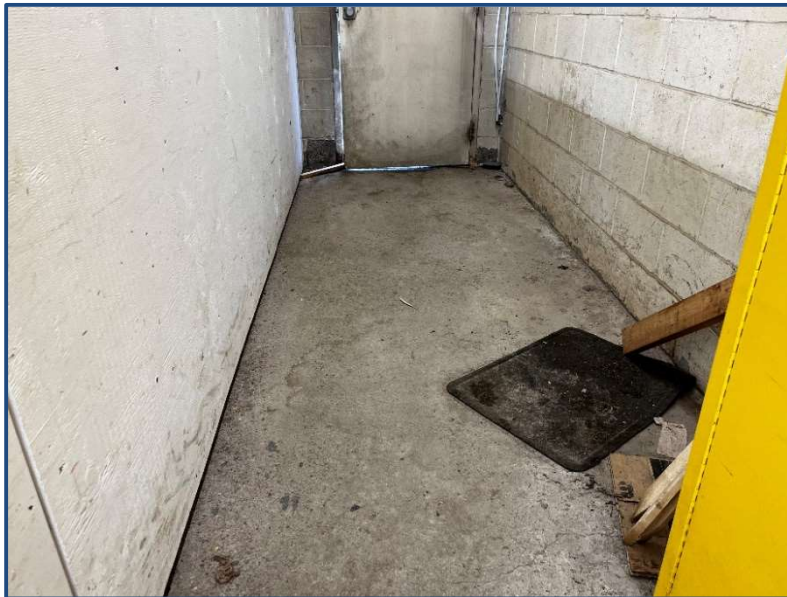
4. Significant water damage noted at base of concrete block and plywood walls in north section. Employees of the Huntsville Operation Centre have noted that the garage bay floods annually during the spring thaw or after heavy rainfall events. The water entering through the north exterior man door and flooding the entire bay, with the drainage system in the floor being inadequate to remove the water.

Picture 44: Water Damaged Wall Section in Garage No. 1

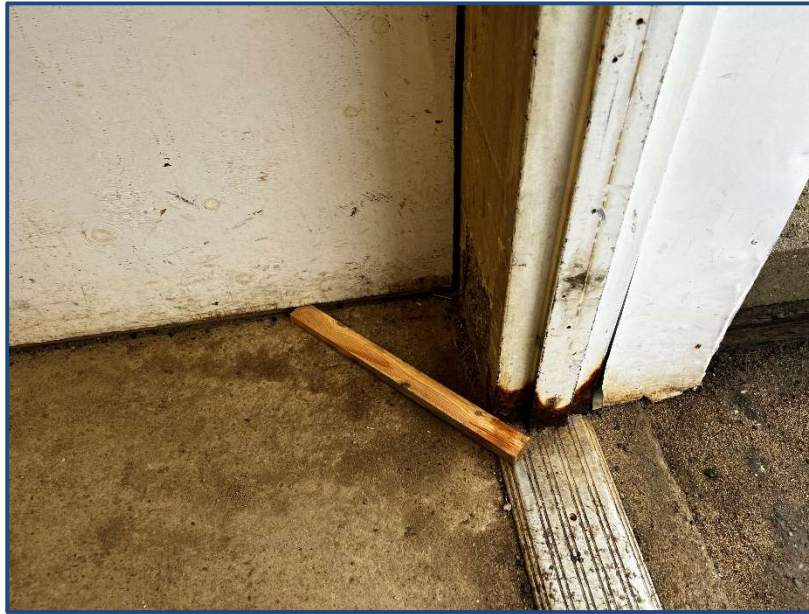
5. The bottom 6 inches of the North exterior man door is corroded.

Picture 45: Corroded Steel Door Frame of North Man Door

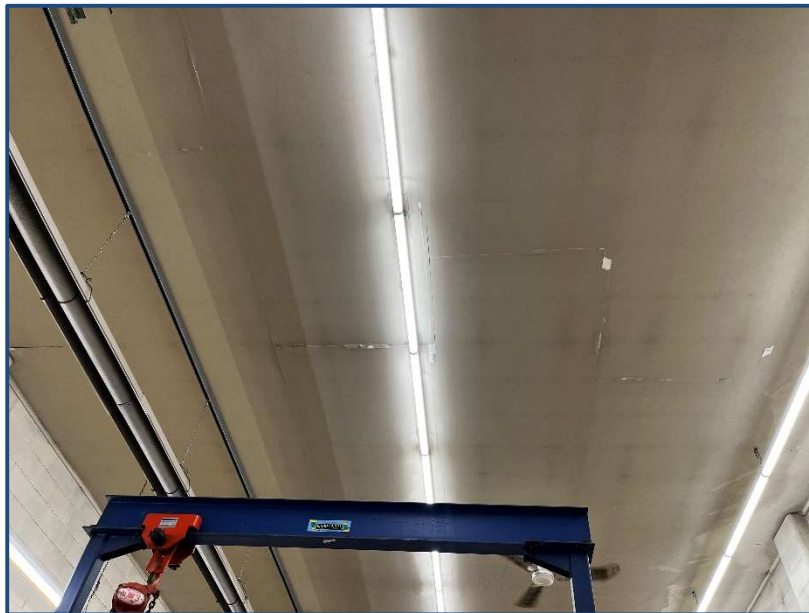
6. Water damage of drywall ceiling and top of the concrete block wall. Ceiling was recently replaced with new drywall and has new water damage. East concrete block wall has most significant water damage at its top two courses.

Picture 46: Water Damaged Drywall Ceiling

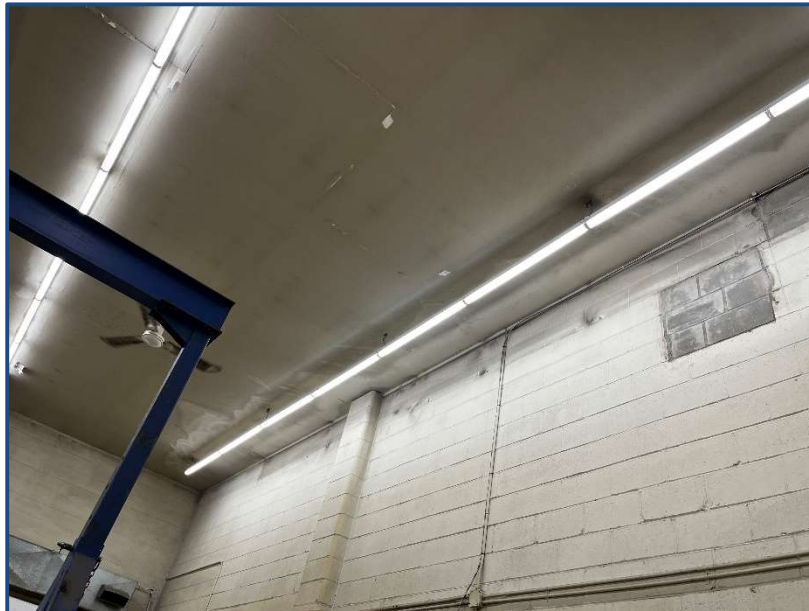
Picture 47: Water Damage at the Top of the East Concrete Block Wall

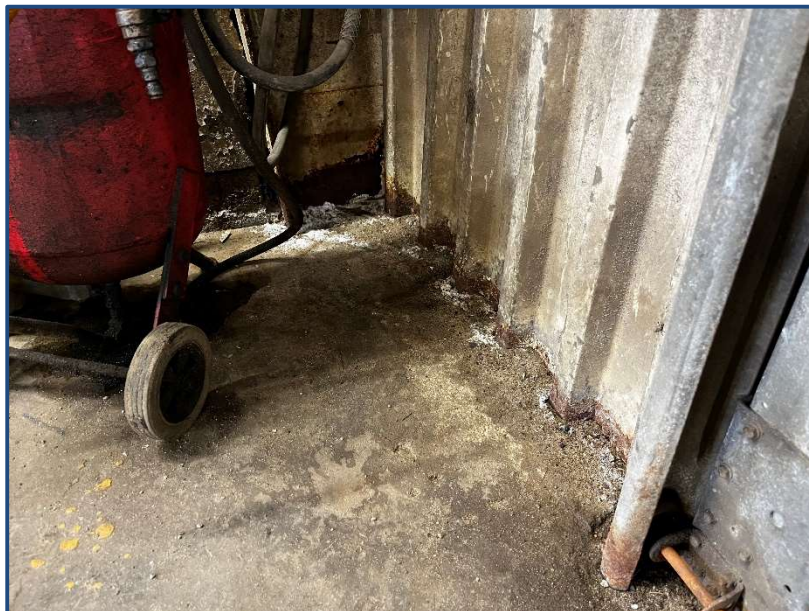
1. Corrosion at base of exposed metal siding.

Picture 48: Corroded Metal Siding – Interior of Garage No. 2

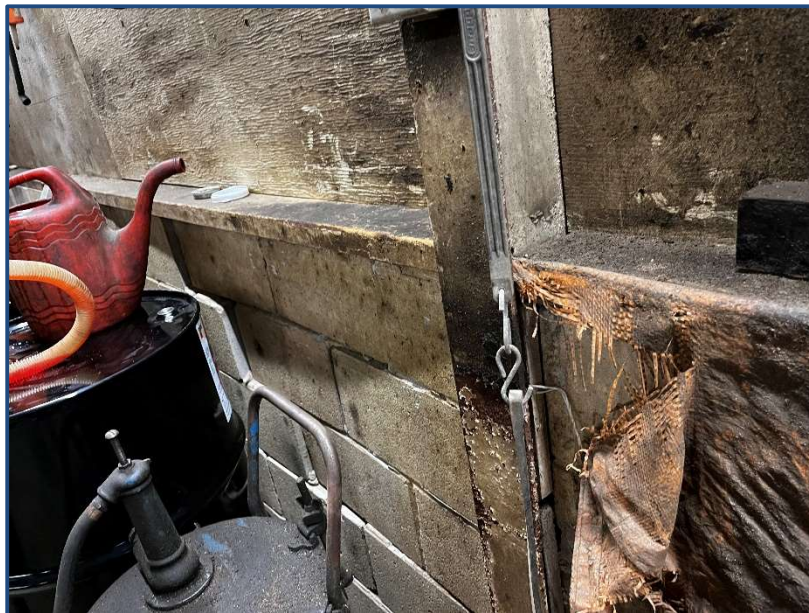
Picture 50: Impact Damage to Concrete Block Wall and Corrosion of Steel Column

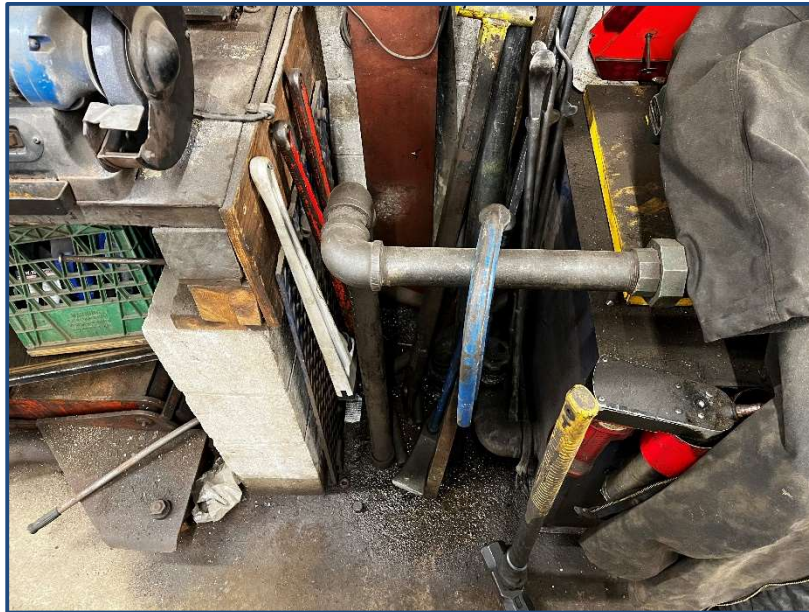
3. Moisture and water leakage at base of north column. Water leakage suspected to be occurring through wall.

Picture 51: Water Leakage through Garage North Wall

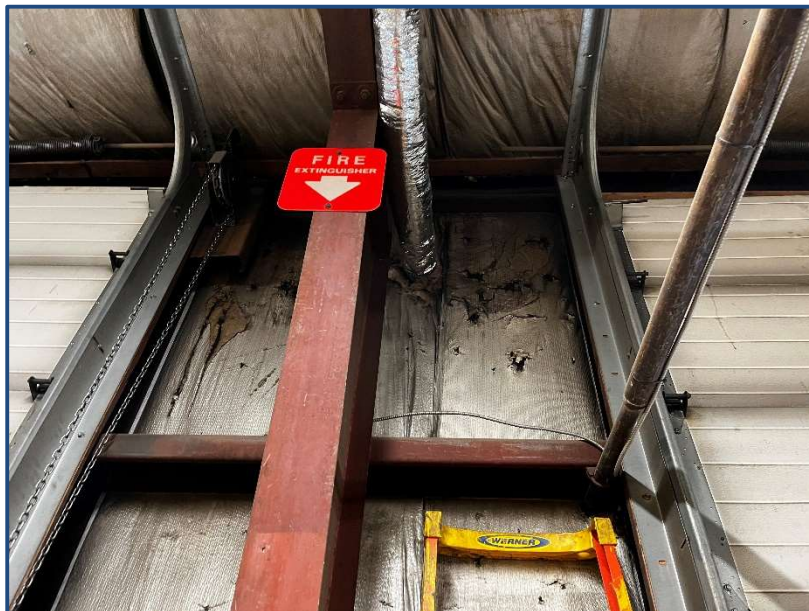
4. Damage to the wall insulation blanket along the south wall of Garage No. 2 at ventilation duct.

Picture 52: Torn Insulation along South Wall of Garage No. 2

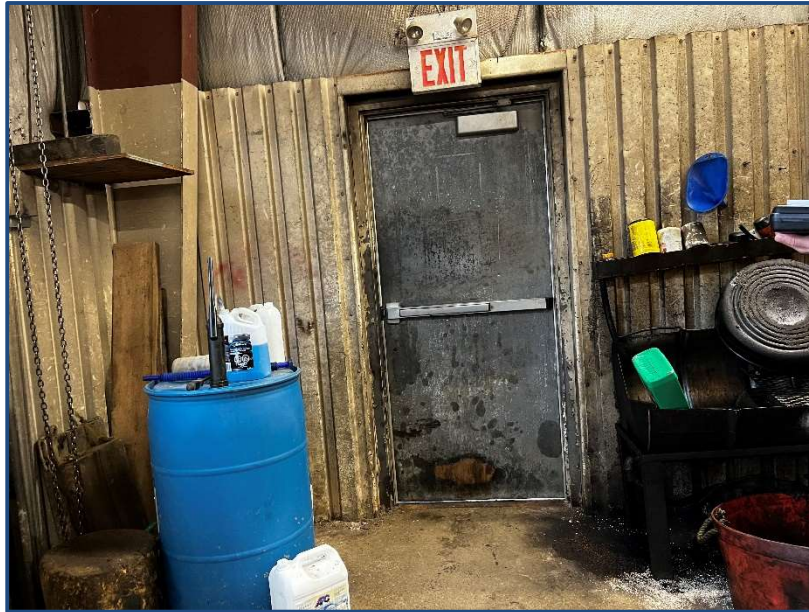
5. Paint flaking and peeling on door and surrounding flashing and siding.

Picture 53: Outdated Emergency Exit Signage at Garage Rear Entrance

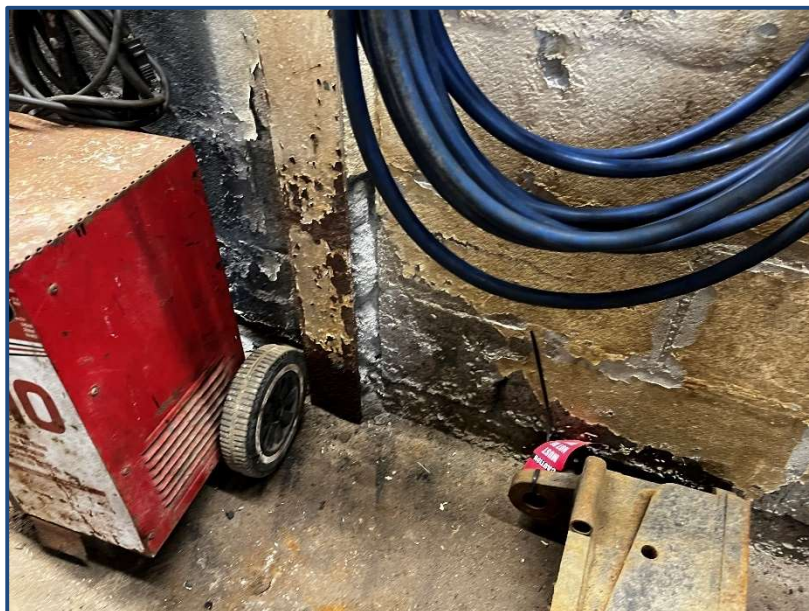
6. The bottom two concrete block courses of the west half wall have severe degradation of the concrete. Paint peeling along the base of the wall.

Picture 54: Degradation of the Concrete Block Wall

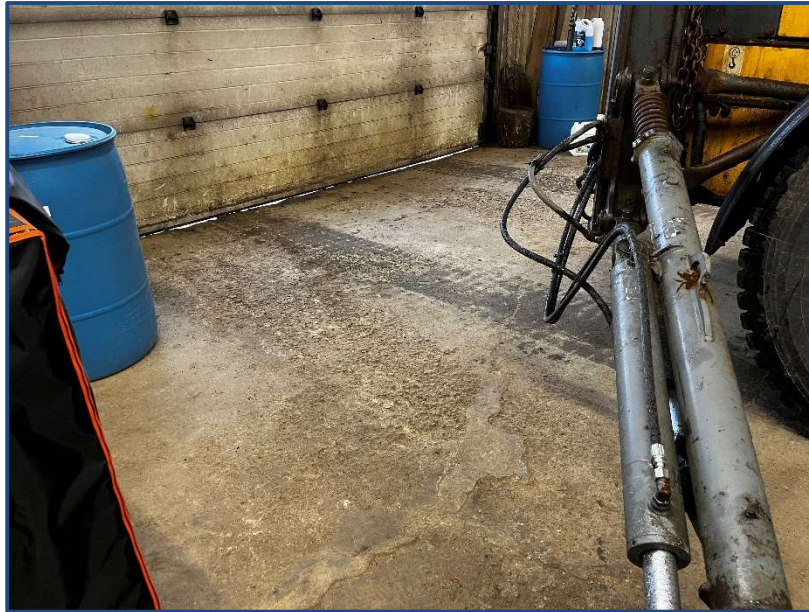
7. General wear of the concrete slab throughout, increased wear at the garage door entrances.

Picture 55: Wearing of Concrete Slab in Garage No. 2 by Garage Door 4

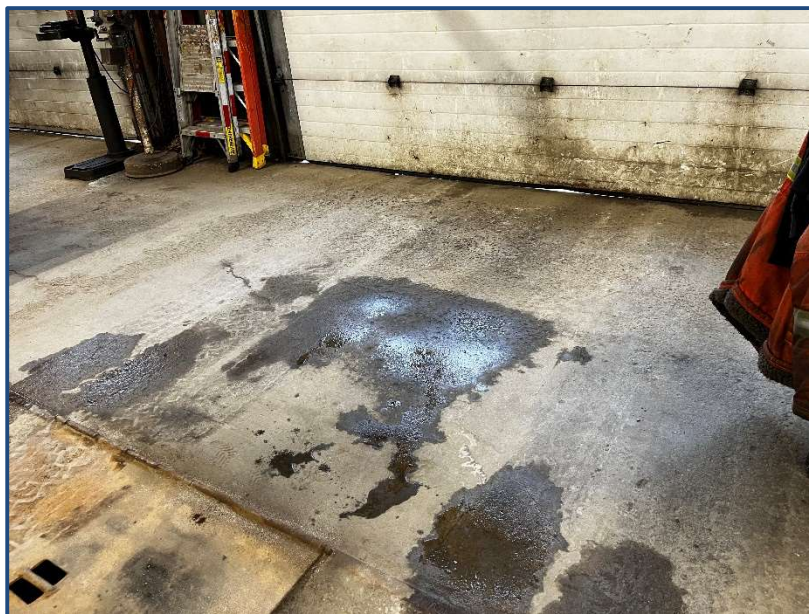
Picture 56: Wearing of Concrete Slab in Garage No. 2 by Garage Door 3

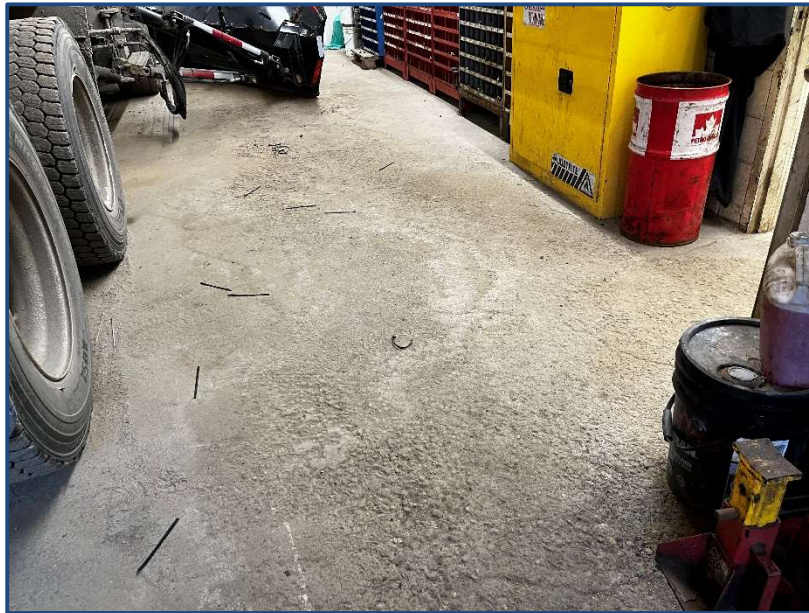
Picture 57: Concrete Slab Degradation at East Wall of Garage No. 2

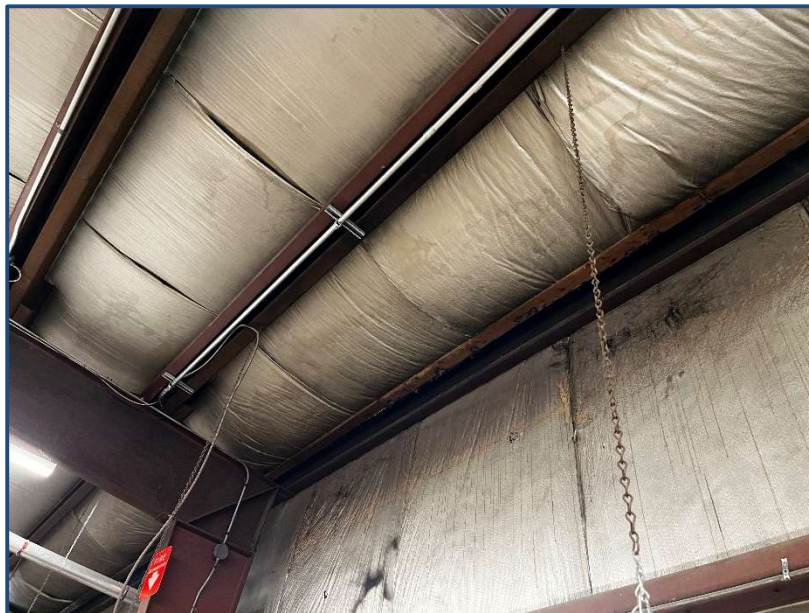
8. The timber strapping along the north wall of Garage No. 2 has rotted. The insulation blankets on the north side of the garage are sagging, demonstrating that they are currently or have in the past held weight, this is most commonly associated with water leakage through the roof.

Picture 58: Rotting Timber 1x4 Plank and Sagging Insulation

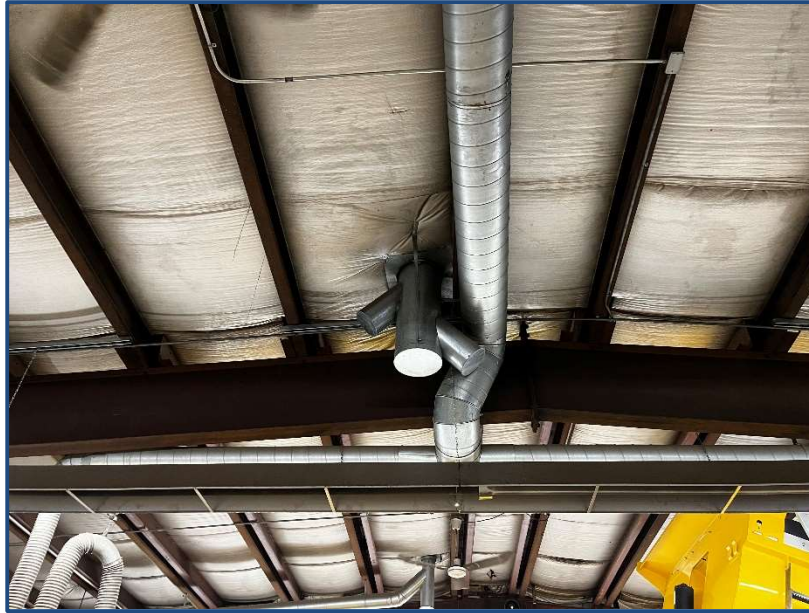
9. The roof above the centre of bay 3 in Garage No. 2 is known by employees of the Huntsville Operation Centre to have severe leaks during rain events or spring melt. Steel roof beam noted to have light corrosion in leakage area designated by the employees. Old ventilation connection within the area suspected to have poor seal with exterior roof causing the leakage.

Picture 59: Area of Severe Roof Leakage in Garage No. 2

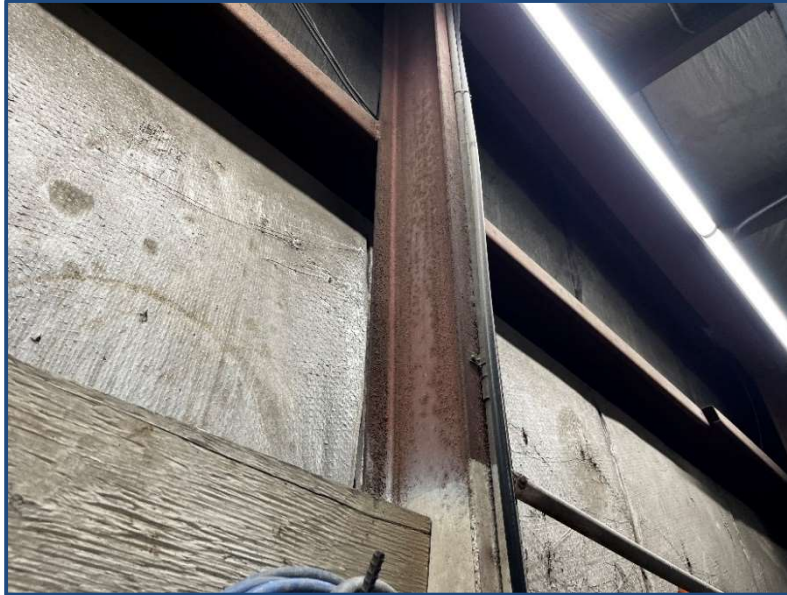
10. Paint flaking and peeling on the western wall steel columns. West columns have light corrosion noted throughout.

Picture 60: Light Corrosion of West Wall Column

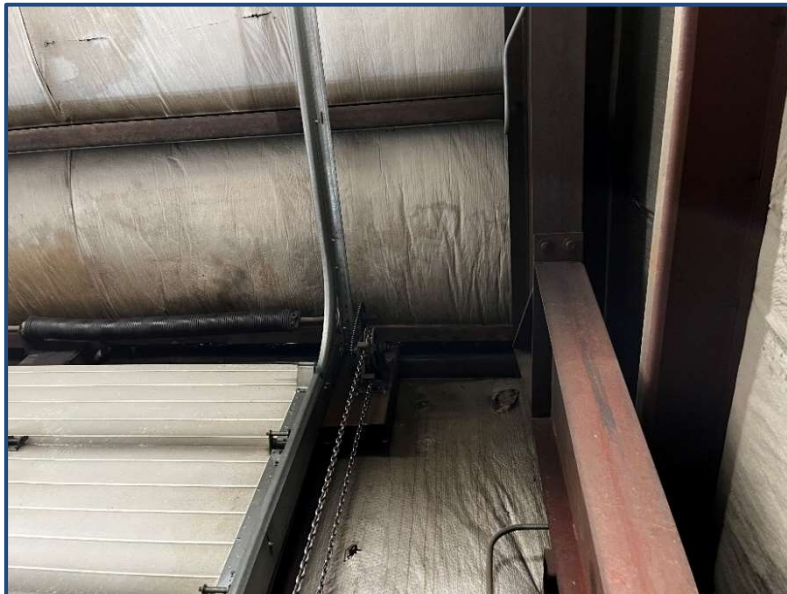
11. Rotation of the roof beam at the beam-column connection in the southwest corner of the Huntsville Operation Centre. Structural capacity assessment has not been completed on the remaining capacity of the beam.

Picture 61: Rotated Steel Beam at Southwest Corner of Huntsville Operations Centre

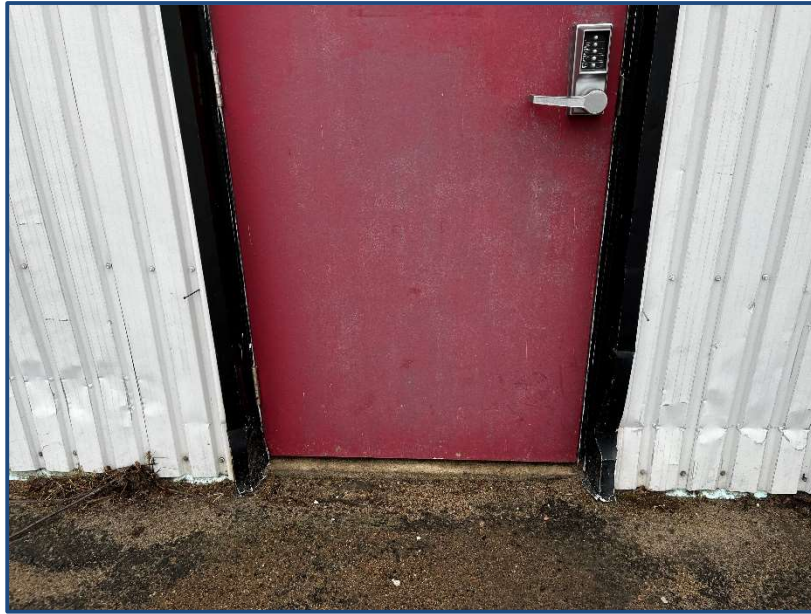
1. No wheelchair access at public entrance to the Huntsville Operation Centre, 2" concrete step grade and no automatic door opener.

Picture 62: Concrete Step and No Automatic Door Opener at Main Entrance

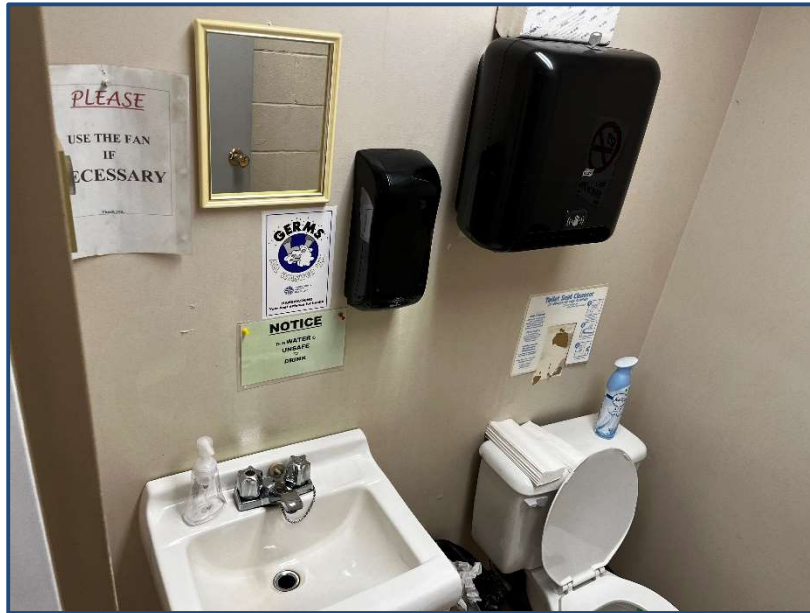
Picture 65: Inaccessible Soap and Paper Towel Dispensers in Women's Washroom

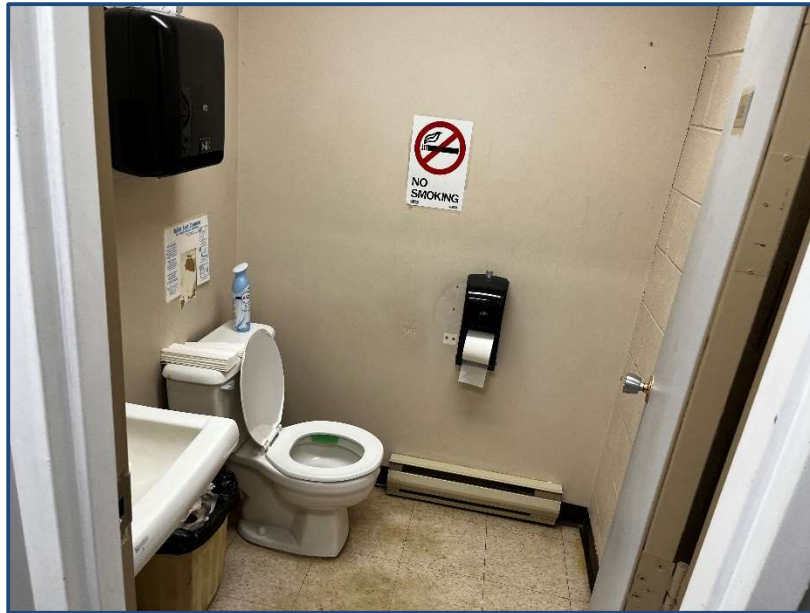
Picture 66: Lack of Toilet Grab Bar Women's Washroom

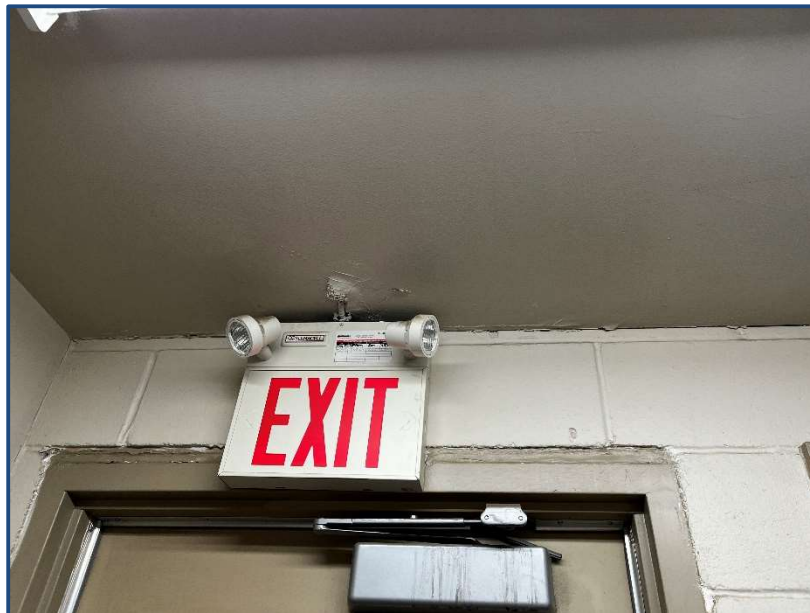
Picture 70: Outdated Emergency Exit Signage – Locker and Lunchroom South Entrance

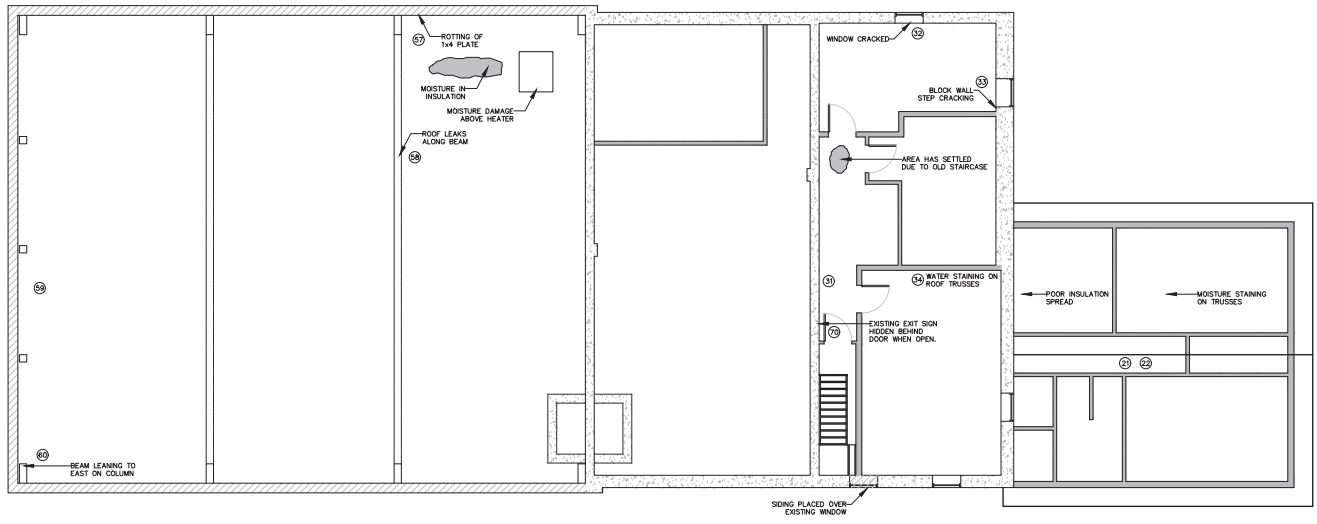
- HUNTSVILLE PUBLIC WORKS GARAGE CONDITIONS:**
1. SECOND FLOOR OFFICE - APPEARS TO HAVE NO LEAKS BUT SLIGHT WATER STAINING VISIBLE IN AREAS. 10\"/>
 2. ATTIC APPEARS TO HAVE MOISTURE STANNING ON THE TRUSSES. POOR INSULATION SPREAD.
