Subject: Town of Huntsville Operation Centre - Madill - Building Condition Assessment

BUILDING CONDITION ASSESSMENT

169 Madill Church Road, Huntsville Ontario

TULLOCH Project #: 21-1405

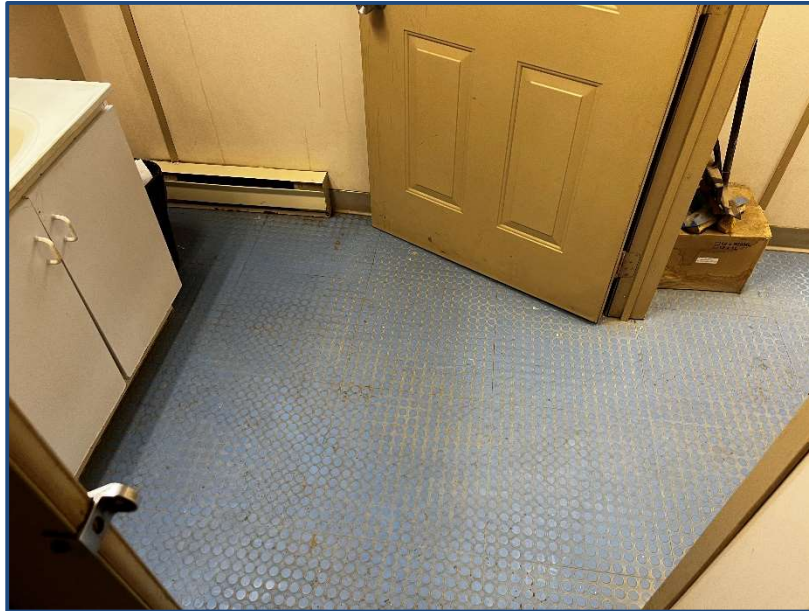
- 2. Men's and Women's washrooms lack accessibility. Neither have sufficient turning radius, accessible soap or paper towel dispensers, accessible washbasin, grab bars, or automatic door openers.

Picture 63: Insufficient Turning Radius in Men's Washroom

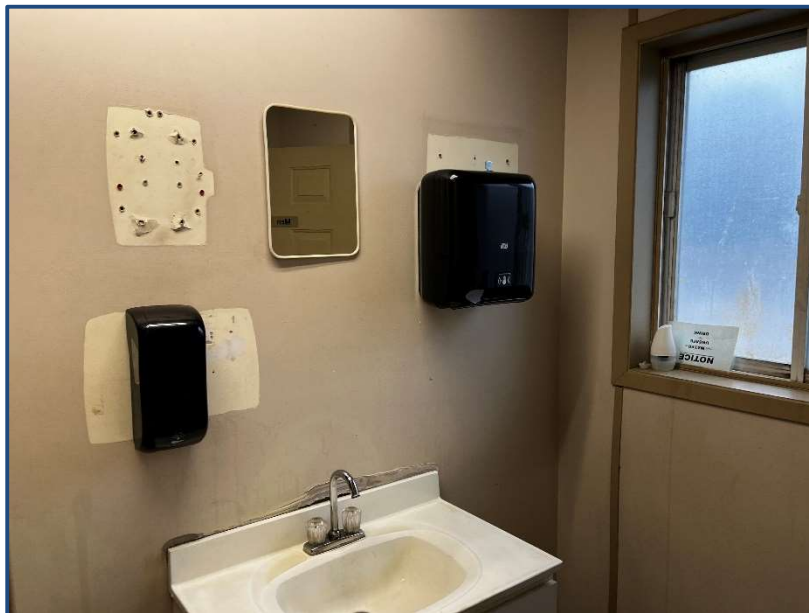
Picture 64: Inaccessible Soap and Paper Towel Dispensers in Men's Washroom

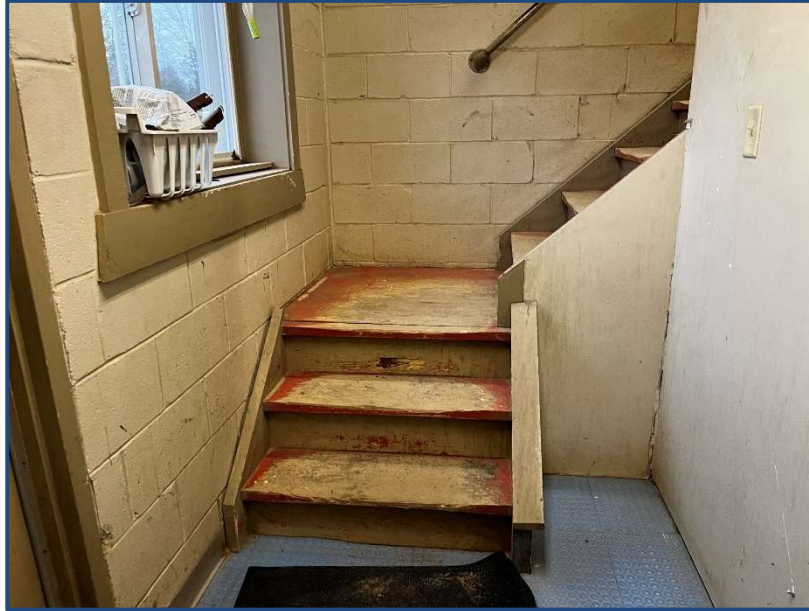
- Handrail provided does not run full length of the stairwell, starting at the top of the first landing. The handrail is connected to the wall in a manner that prevents the railing from being graspable along its entire length, as is required by the current Ontario Building Code.

Picture 67: Staircase Base and Landing – Termination of Handrail

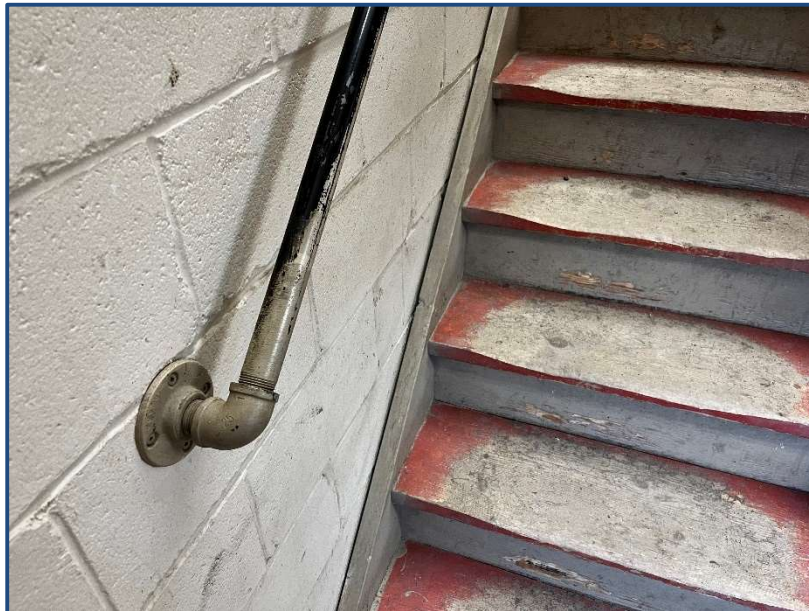
Picture 68: Handrail Connection to Wall

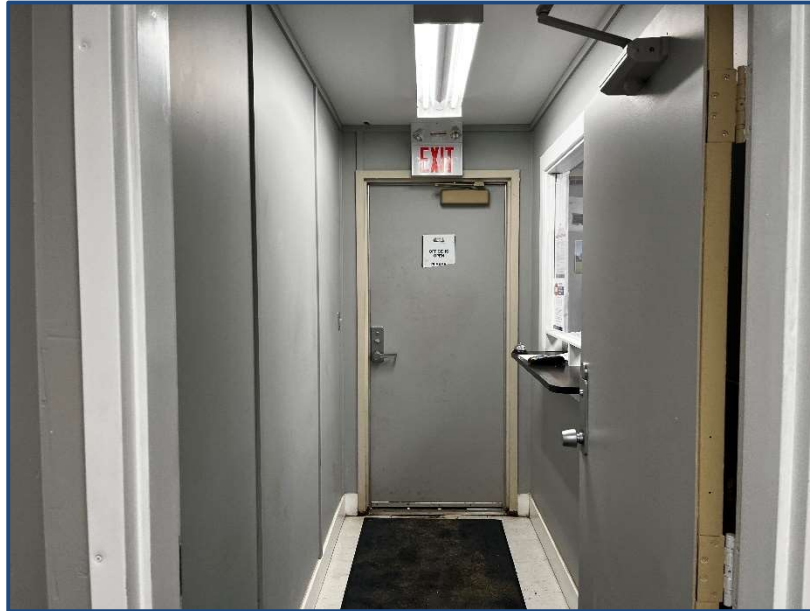
4. The emergency signage for the building is outdated with respect to the current Ontario Building Code. The signage and lights are concealed in the Second Floor Offices behind a door.

Picture 69: Outdated Emergency Exit Signage – Huntsville Operation Centre Main Entrance

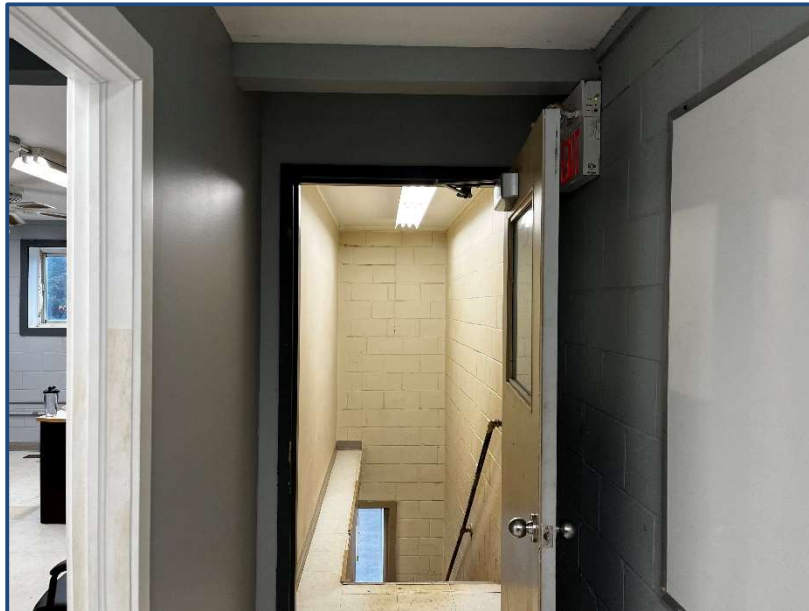
Picture 71: Concealed and Outdated Emergency Exit Signage – Second Floor Offices

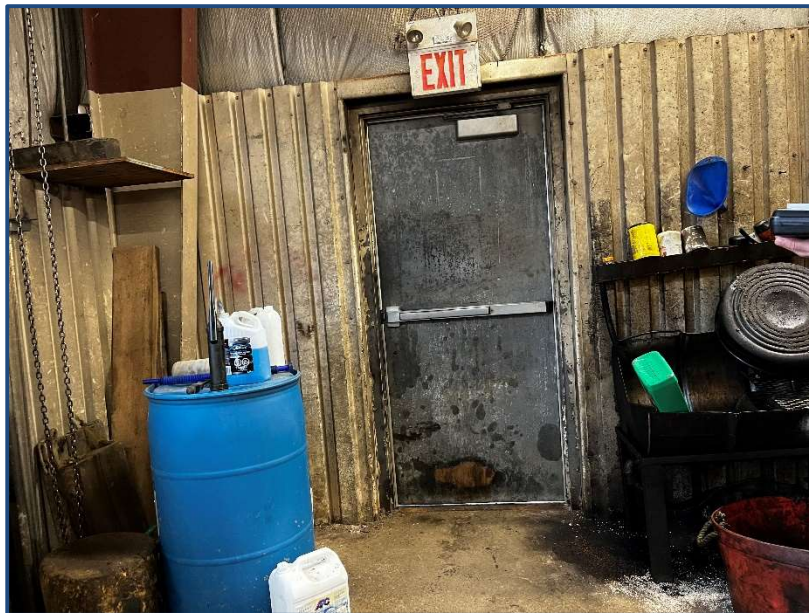
Picture 72: Outdated Emergency Exit Signage – Garage No. 2 Rear Entrance

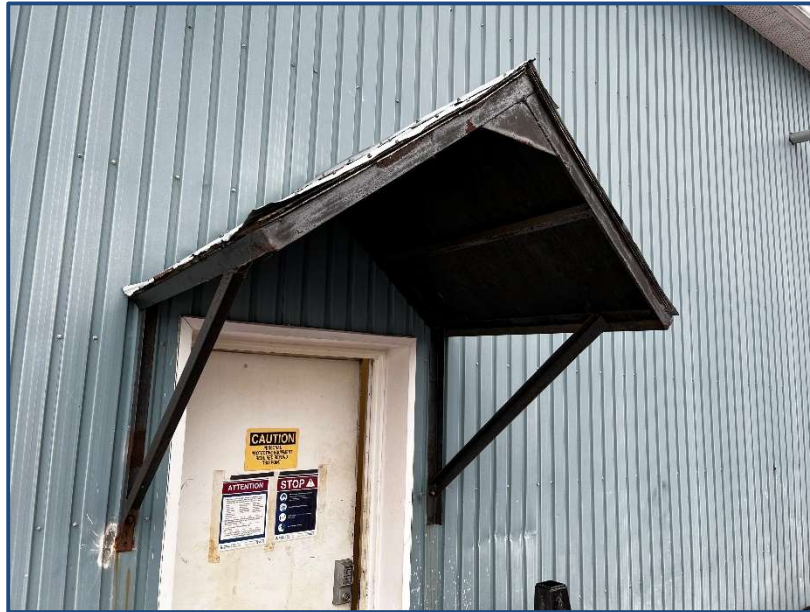
- Garage No. 1's north man door exit opens inwards. Buildings of this type are required to have the exterior entrances/exits that open outwards.

Picture 73: Garage No. 1 North Exit Opening Inwards

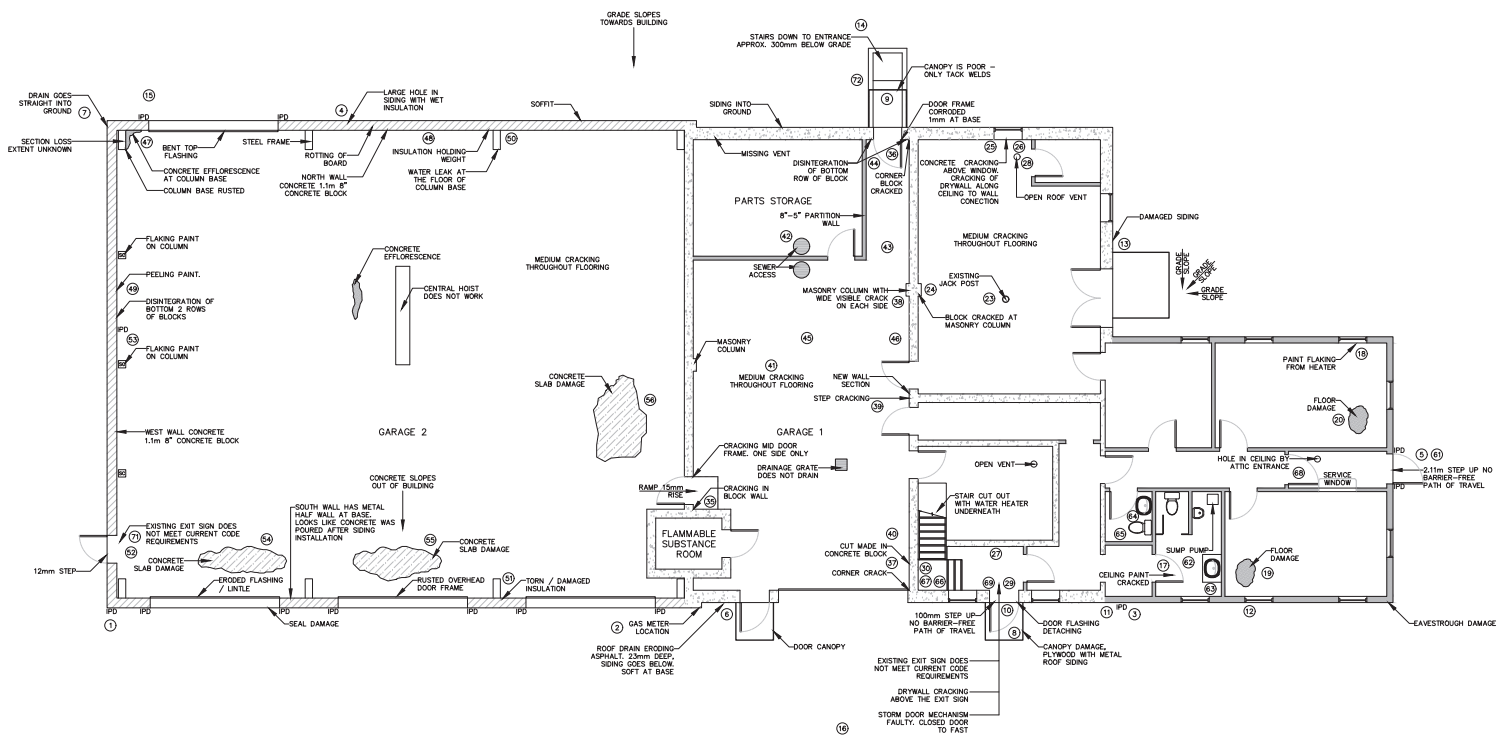
HUNTSVILLE PUBLIC WORKS GARAGE CONDITIONS:

1. ROOF LEAK IN FIRST BAY STARTED IN 2021
2. OFFICES HAD COSMETIC FIX-UPS IN 2021
3. STAIRCASE HAS SETTLED OVER FLOOR IN HALL CRACK LOCATED IN WALL BY STAIRS
4. NO PROPER VENTILATION IN WASHROOM
5. INFESTATION OF RODENTS IN WASHROOM AREA.
6. FRONT OFFICE - RENOVATION DONE IN 2019 - TRIM IS SEPARATING, FLOORING UNDER DESK IS FADING, NO INSULATION IN WALLS (BIRD IS FELT FLOWING THROUGH) AND THE CEILING DRYWALL HAS CRACKS.
7. LUNCHROOM - RENOVATION DONE IN 2018 - JACK POST IS ORIGINAL.
8. GARAGE BAY 1 - STORM WATER DOES NOT DRAIN PROPERLY, LARGE CUT IN SLOOF WALL BY GARAGE DOOR AND SEWER ACCESS, DRAINS LOCATED WITHIN THE GARAGE, HAVE A SMELL OF GAS AND SEWAGE, THESE DRAINS RUN TO THE PARKING LOT.
9. GARAGE BAY 2 - IN FLOOR WASTE CONDENSED AND THERE IS ICE DAMMING IN THE WINTER.
